**17/01834/FUL - HISTORIC BUILDING RECORD**

**7 BARTON VILLAGE ROAD, BARTON**

**OXFORD**

**AUGUST 2020**

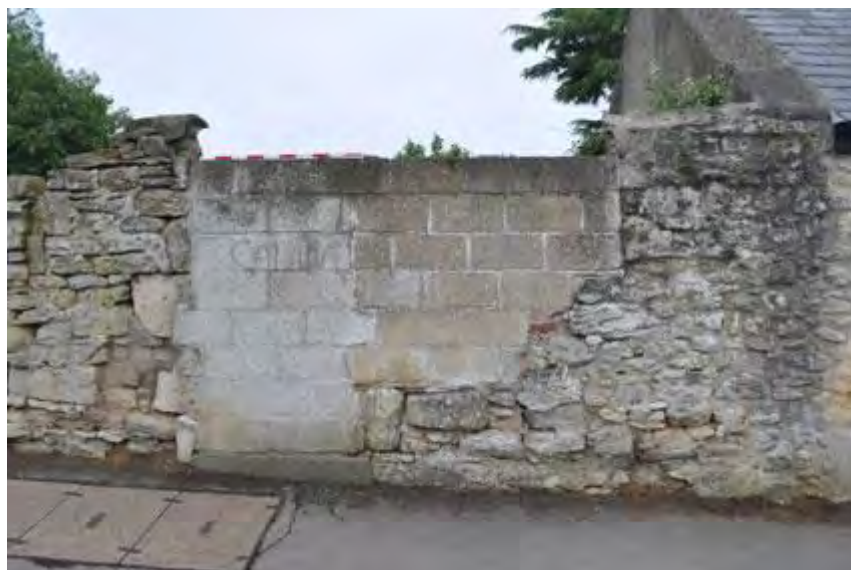
Plate 1: South-east Face of wall North Part

The surviving east boundary wall at its north end is joined to a single storey wing of 7 Barton Village Road, otherwise referred to as Barton Manor (Plate 1, Fig. 2). There is no butt joint between these two parts of walling and it is thus believed that they were once part of the same structure. This first section of limestone wall is a reverse L-shape. On the left hand side, there is a limestone quoin that would have marked the lower part of a door surround. There are a further group of quoins that would have marked the upper part of the wall to the north. These quoins mark the former locations of a door and window that have now been filled in with breeze-blocks. These have been squared in with the use of brick and tile. There is a door step to the south of this stone wall.

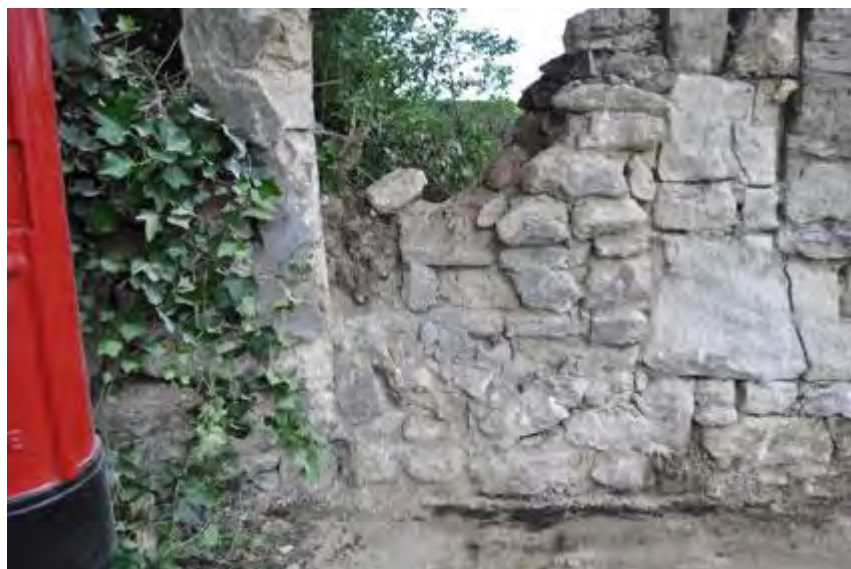
Plate 2: Earliest doorway, blocked with stone

To the south of the doorstep, there is a further section of limestone rubble walling. This has a number of door quoins on the north end that would have defined the one side of the former doorway (Fig. 2). To the south of this, there is a blocked window that had limestone quoins, and which had been infilled with limestone rubble blocks. To the south of this, there is a partial butt joint that appears to indicate that the two structures did not originate at the same time. The butt joint does not extend to the floor, so it is tempting to think that they were constructed onto a limestone boundary wall. To the south of this butt joint, it is possible to identify further quoins that were associated with the outline of a further window. The limestone wall runs under a group of breeze block insertions, which occupy the location of a former window. This runs up to a series of quoins that mark the location of a further doorway, which was also filled in with breeze block walling.

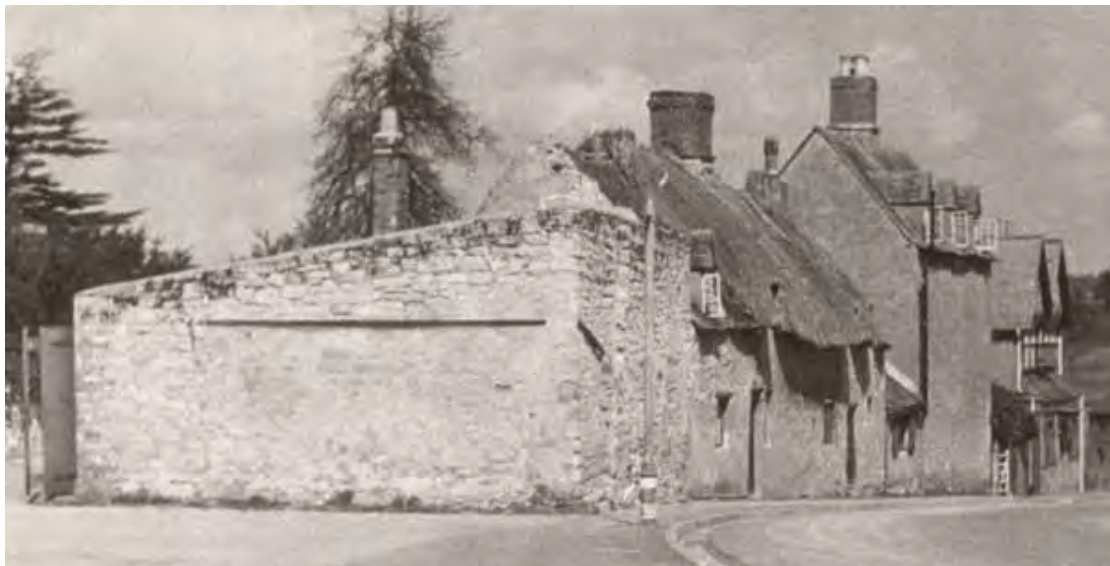
Plate 5: Old photograph of Barton Manor

photographic evidence (plates 5-6) indicate that there was a building to the south and that this had a probable doorway in its north-east facing wall as well as its south-east facing wall that is on the photograph. It is presumed that this is a doorway, the alternative is that this was the location of a further return wall to the south. To the west of the presumed door in the central part of the wall there are the partial remains of two blocked windows. If the quoins are part of a central door in the north-east facing exterior wall then the whole structure appears to be part of a medieval hall, which had greatly decayed by the late 19<sup>th</sup> century.

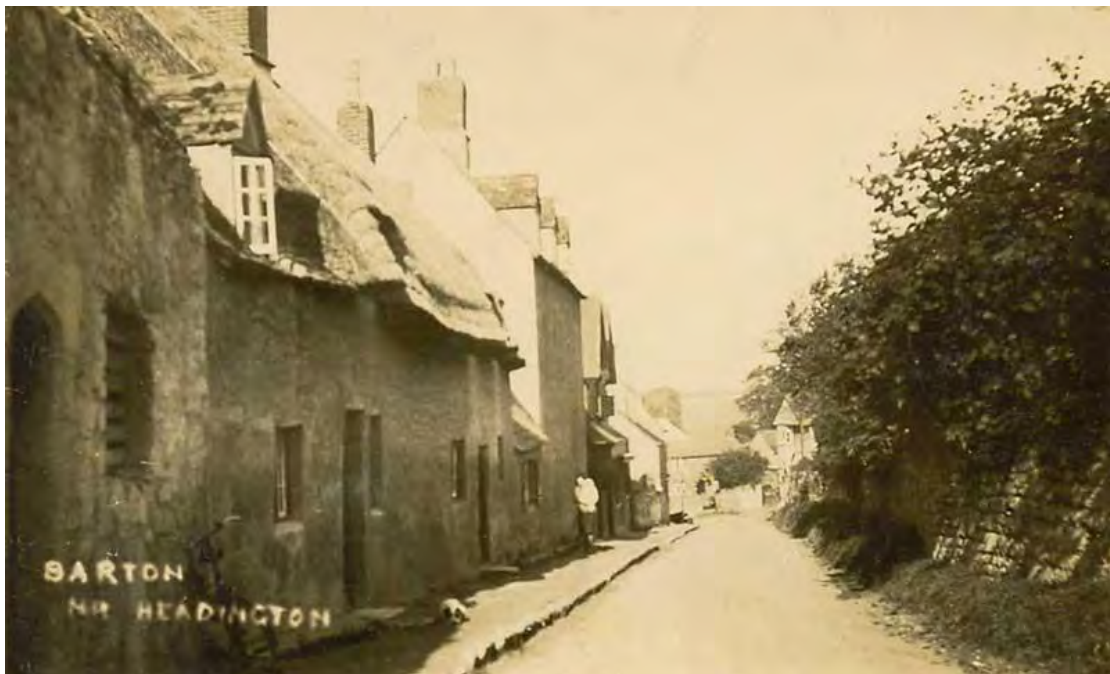
Plate 6: Old postcard of Barton Manor

The assessment of the south-west wall and its relationship to the south-east wall is suggestive of the south-west wall predating the south-east wall on the site. There are various aspects about this wall, its greater width (0.90m), the apparent return wall to the south, and even the manner of its construction that suggest that it is earlier. The architectural detail, the Gothic arch, on the surviving photographs of the return wall to the south (Plates 5-6) attached to the south-west wall are indicative of this wall being dated to the 13<sup>th</sup> or 14<sup>th</sup> century (Yeates 2013), or 15<sup>th</sup> century at the very latest. This arch is particularly evident on plate 6.

The two cottages that were located on the plot of land developed were butted up to this southern building. It is apparent that on the old postcard photograph (Yeates 2013: plate 6) that the south door of this building is blocked and has render over its surround. This is suggestive of this doorway predating the other two doorways in the structure and belonging to a previously unrecognised phase of the building. This doorway has the largest quoins and the best dressed stonework around it. The quoins on either side of the doorway appear to be slightly different, and the two walls on either side are of different widths. These large stones on the north side key into the lower part of the wall, which is significant and does not occur with the other two doorways. The stonework extends up around the doorway, but there is a butt joint adjacent to it, perhaps indicating that the stone surround carried up around this doorway at an early date.

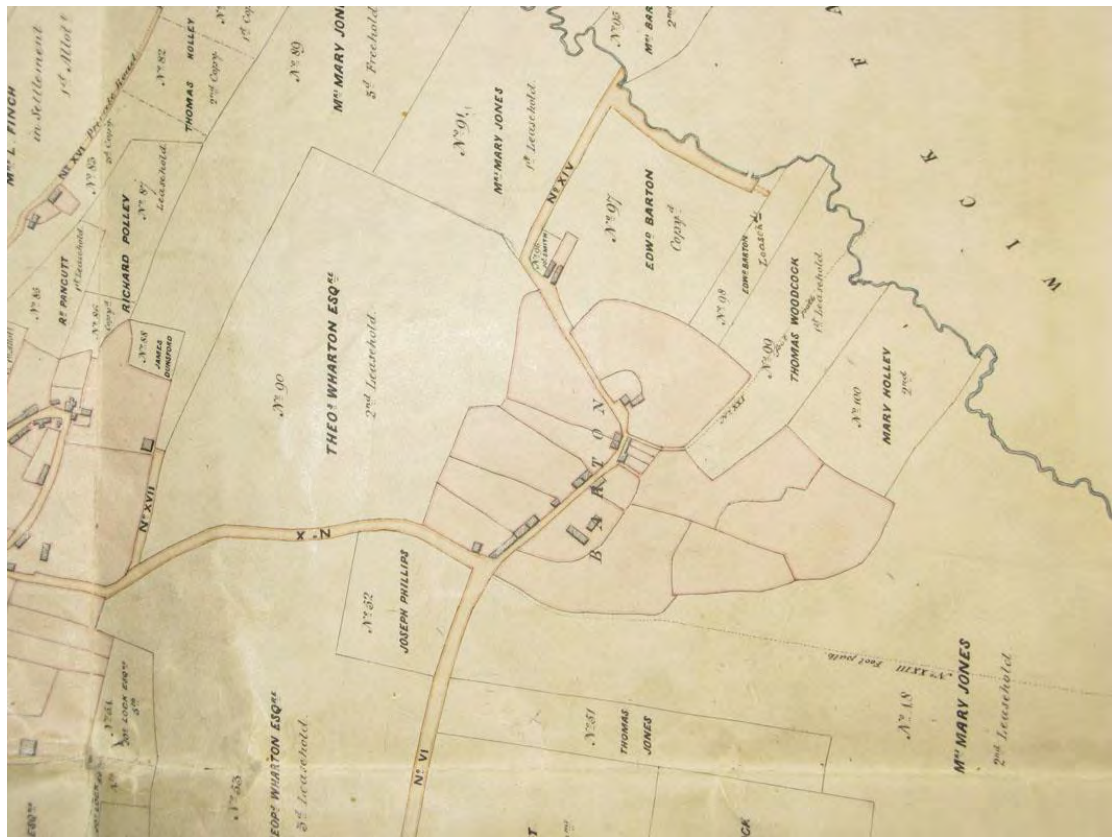
Figure 6: Headington Inclosure Map of 1805 (PAR126/16/H/2) © Oxfordshire History Centre. North to top

Figure 6 shows the Headington Inclosure Map of 1805 (PAR126/16/H/2), the buildings concerned are those located on the south side of Barton Village Road on the west side. The ditch identified in the evaluation lies behind these buildings in a relatively central location. On the east side of Barton Village Road there is part of a curving boundary that is located in the right location to be a continuation of this ditch, thus potentially representing a relic boundary in the early 19<sup>th</sup> century. If this is all part of the ditch system, then it could just be a ditch around the village.

The Headington Inclosure Map of 1805, shows the house now colloquially known as Barton Manor is joined to the cottages and lies in the same curtilage. This could imply that it was a replacement to the southern building, but it also implies that the alterations to the central cottages may have been carried out at the same time or in close succession.
