**OLD ST MICHAEL'S CATHEDRAL,  
ST MICHAEL'S AVENUE, COVENTRY**

**ARCHAEOLOGICAL MONITORING AND  
INVESTIGATION REPORT**

**FEBRUARY 2016**

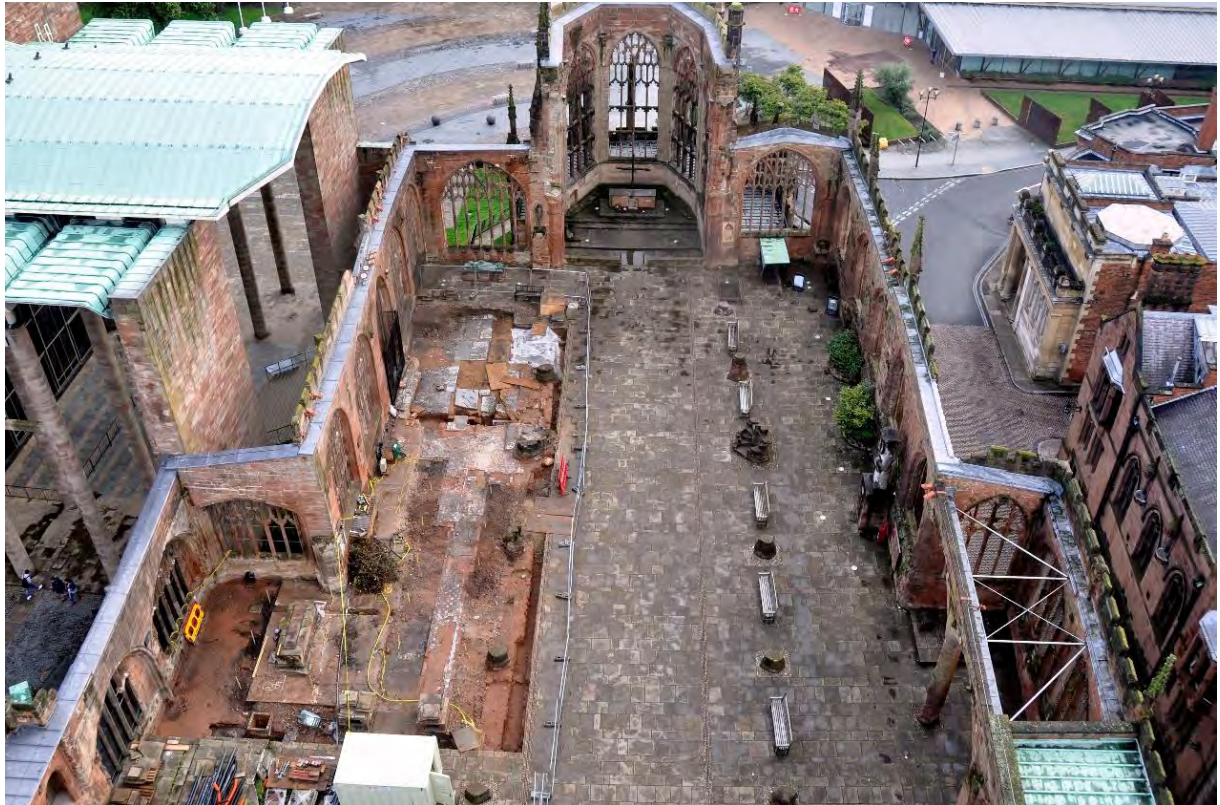
*Plate 1. General view of excavation area within the eastern end of the north aisle (over the crypt of St Laurence and in the area of Draper's or Lady Chapel) Girdler's Chapel is far left. View to east.*

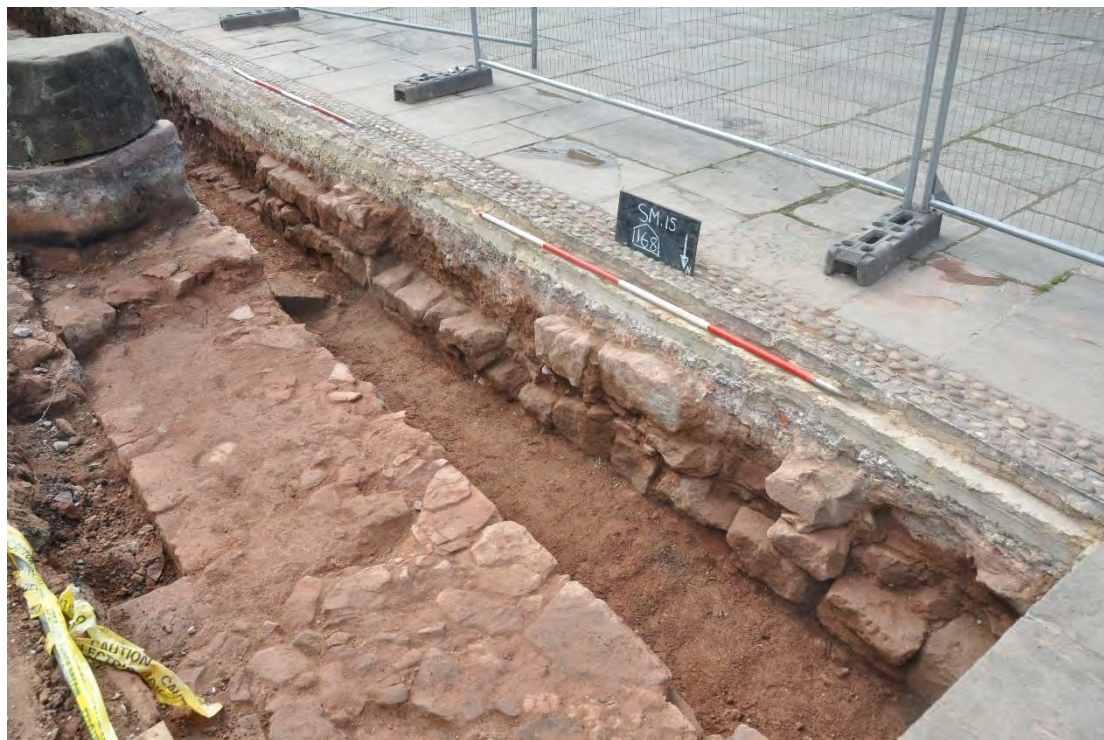
**Plate 2.** Wall 168. Note: Grave cut 162 (upper left) and probable Grave 184 (centre). Wall 171 (bottom centre) and Wall 172 (left) are also visible. Deposits over the roof of the West Crypt (far left middle) are also visible. View to south-east.

Wall foundation 168 was revealed on the south-west side of the drainage trench excavation (Figs 2, 3; Sects. 16, 18; Plate. 2), aligned east-west. It was visible for a length of 7.5m and survived to a maximum height of 1.18m (88.72m - 87.58m AOD). The southern side of the foundation extended beyond the excavation and only 0.28m of its width was visible in plan. It survives at 0.3m (88.72m AOD) below the current ground level.

Wall 168 had also been truncated by a shallow feature (184) which may have represented a shallow grave. This was aligned east-west (Fig. 3; Sect. 16) and measured 1.3m in length and was 0.4m in depth. The observed width was just 0.28m, the southern extent of the feature was beyond the southern limit of the investigation. The feature was filled with soft, mid reddish brown sandy silt (185), containing frequent fragments of slate from a broken memorial stone, and moderate quantities of tile and charnel (including a fragment of skull).

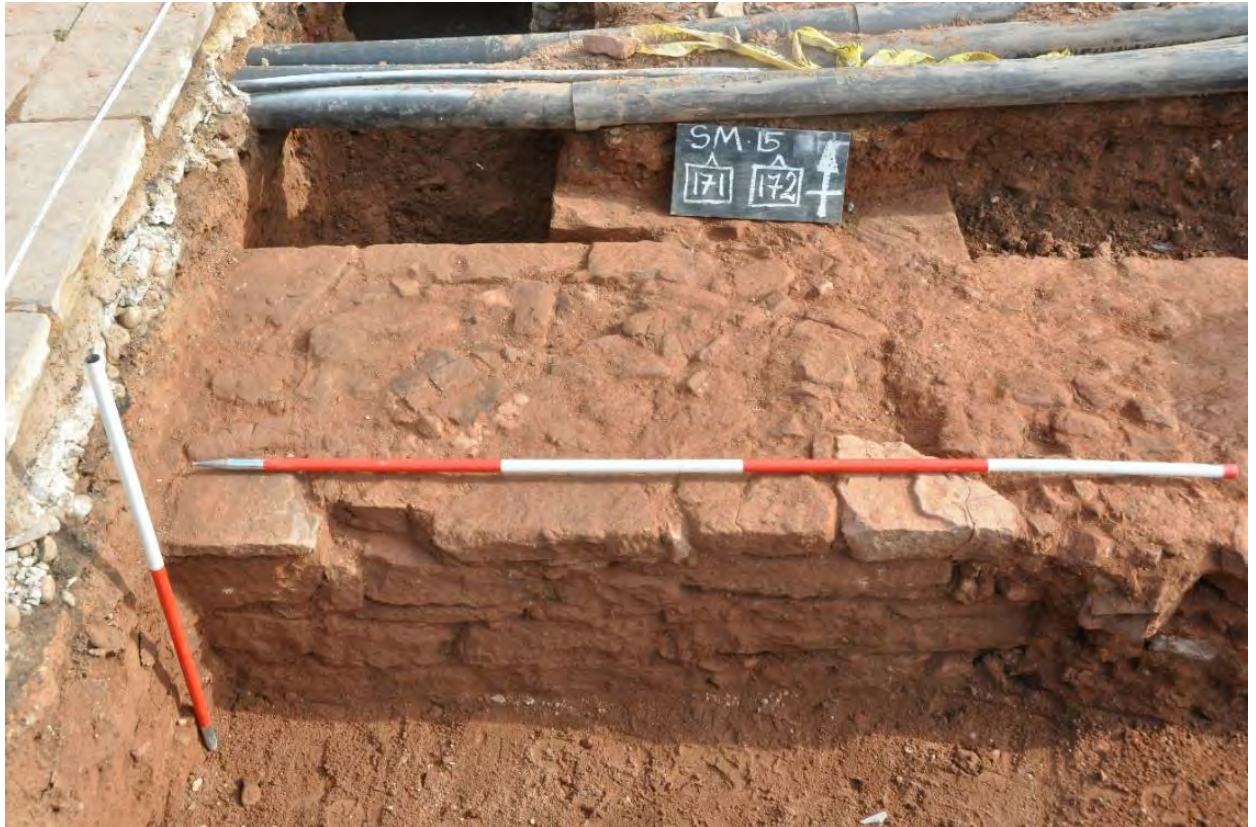
*Plate 3. Walls 171 (left) and 172. The truncation of Wall 171 to the east by Wall 172 is clearly visible.*

Wall 171 is estimated to be 1.3m wide at the base, although not fully revealed. It was 1.08m wide at its highest point. The south face of the wall was constructed from roughly hewn, reddish brown sandstone (average dimensions 0.38m x 0.26m x 0.12m), with two small foundation steps; each measuring 0.28m in height, with 0.04m stepped offsets (Fig. 3; Sect. 18; Plate. 2). The north face was constructed from four courses of sandstone 0.68m in height (as seen). The lower two courses were constructed from roughly hewn sandstone, whilst the upper two courses have been constructed from dressed stones with 45° bevel chamfers, 0.42m in height. The height of the two chamfer courses differ; the top course was 0.24m high, the lower 0.18m high (Fig. 3; Sects. 23, 24; Plates. 3, 4).

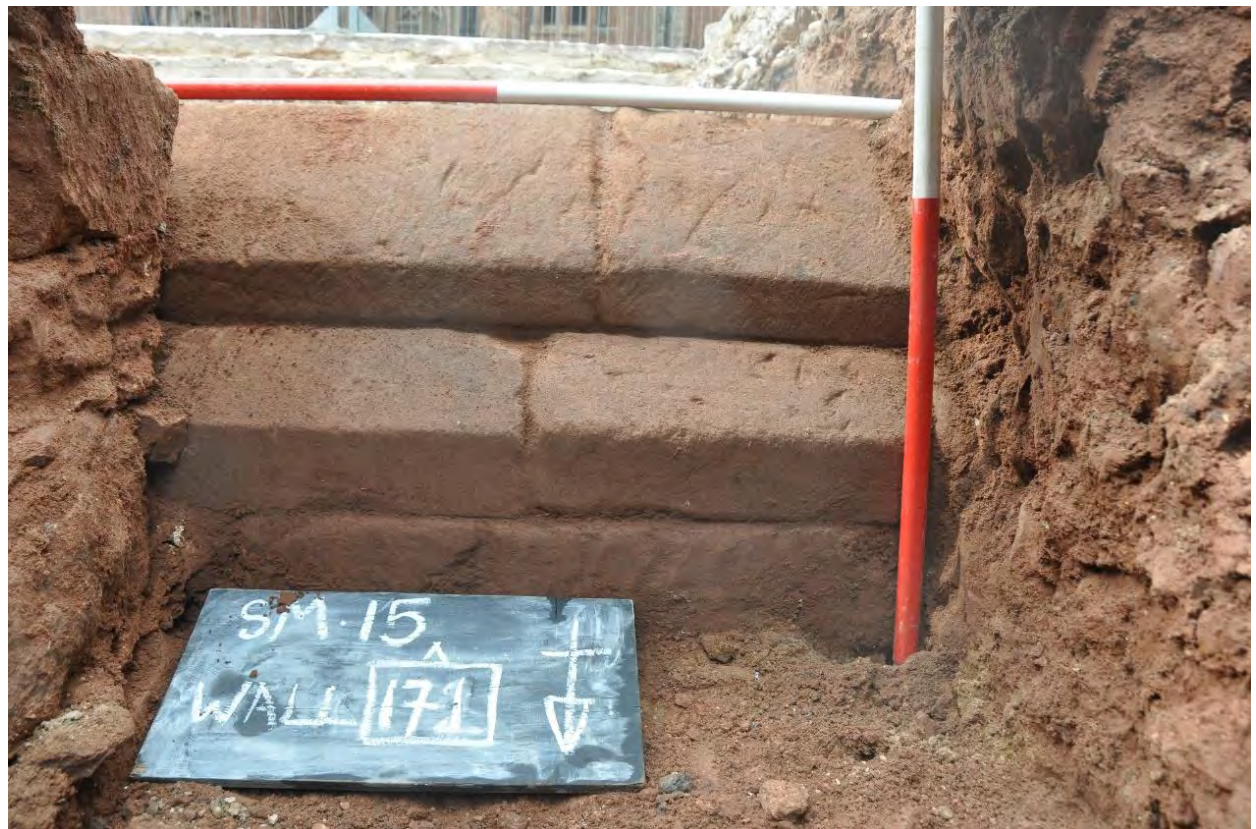
*Plate 4. North face of wall 171 with chamfer courses. View to south.*

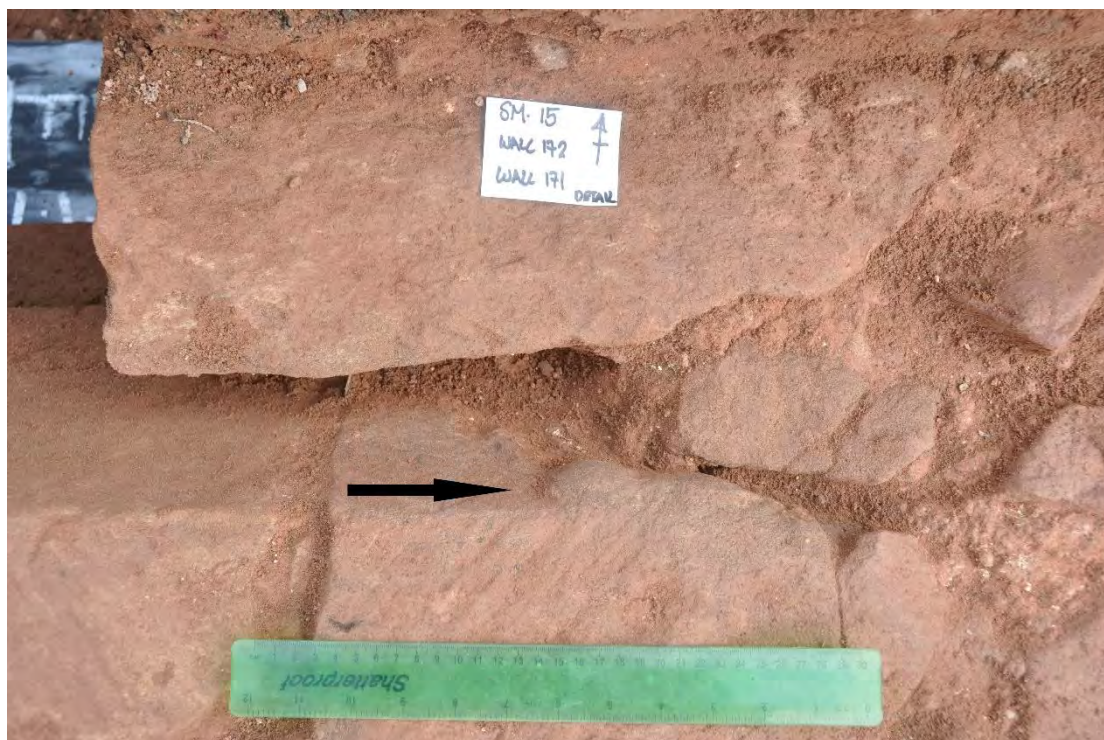
**Plate 5.** Detail of buttress scar (arrow) on north face of Wall 171, cut to east and abutted to north by Wall 172.

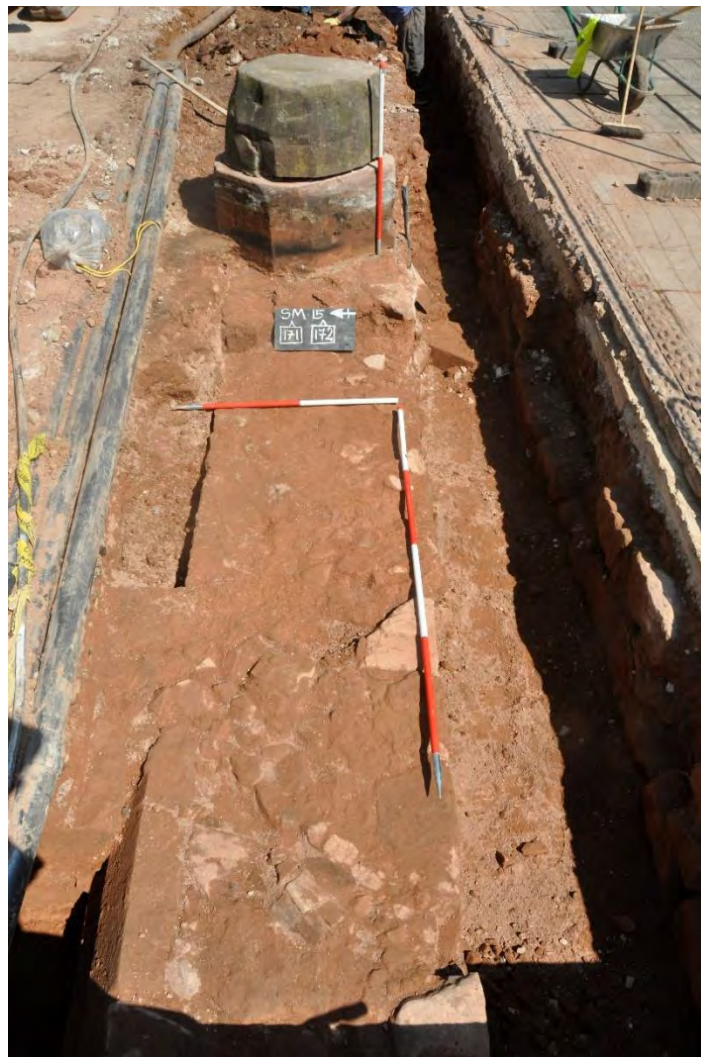
**Plate 6.** Walls 171 and 172. Note the SW corner (mid left) of the West Crypt formed by wall 172, contains deposits (179, 180) overlying the crypt roof. Wall 171 in foreground. The division between Walls 171 and 172 is clearly visible.

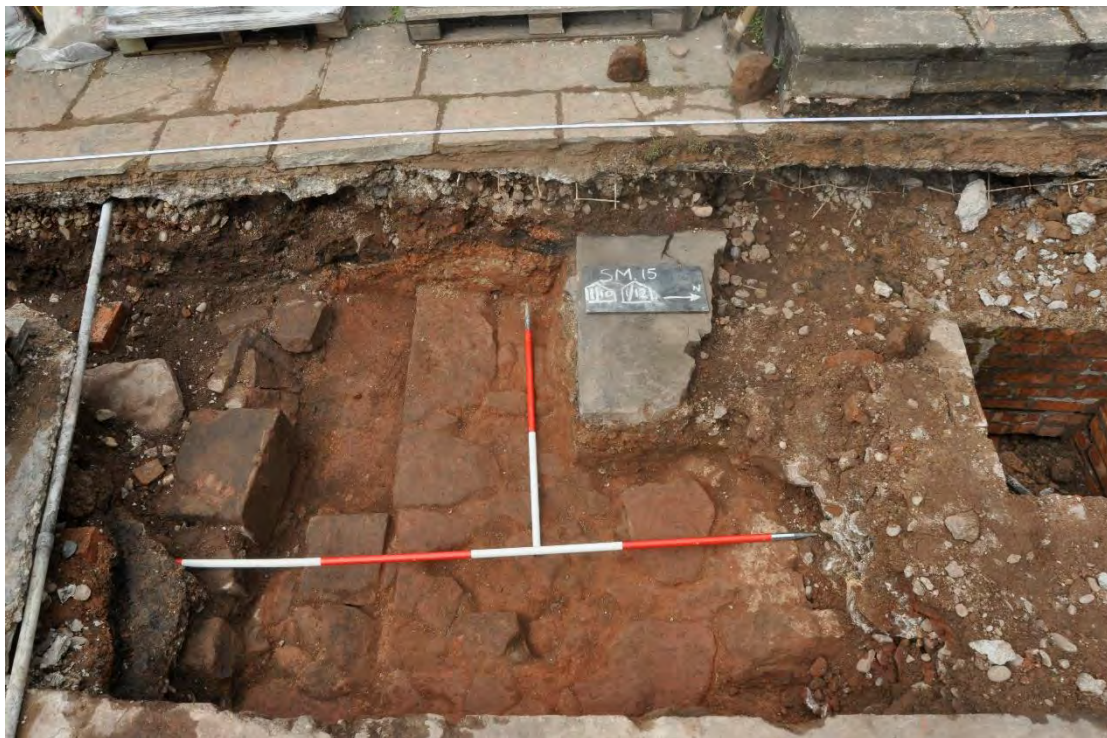
**Plate 7.** N-S Wall 238 (Test Pit No 1/12) to left, truncated (?) by E-W Wall 232 (Test Pit No 1/10) centre. Possible buttress to north of Wall 232 is just visible. Note modern disturbances- West crypt's air vent to south, man-hole (186) to north. View to west.

The northern extent of the wall appears to have been truncated by the construction of Wall 232 (see Phase 5 below). Its visible dimensions were, 0.6m (N-S) x 0.8m (E-W), although a large rectangular sandstone block (Plate 7. visible on left) almost certainly represented part of the wall disturbed during construction of an air vent, making the wall originally 1.2m wide, and in alignment with the west face of Wall 172. It was constructed from roughly hewn sandstone (average dimensions 0.3m x 0.3m) laid in random courses (as seen), and bonded with a pale yellow/brown sandy mortar.

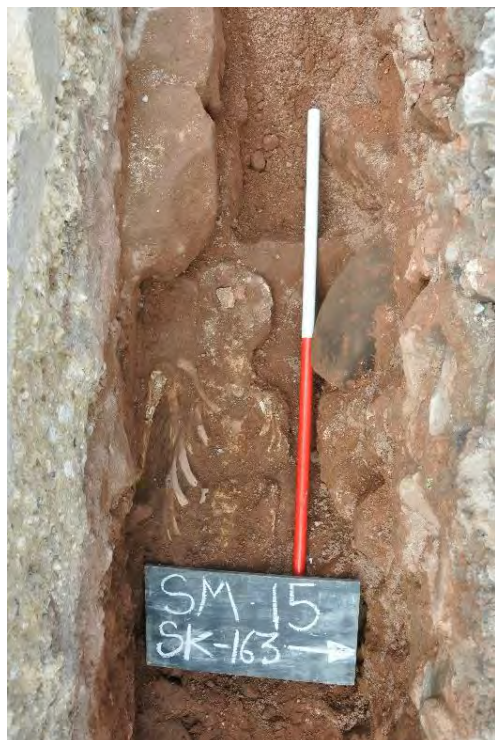
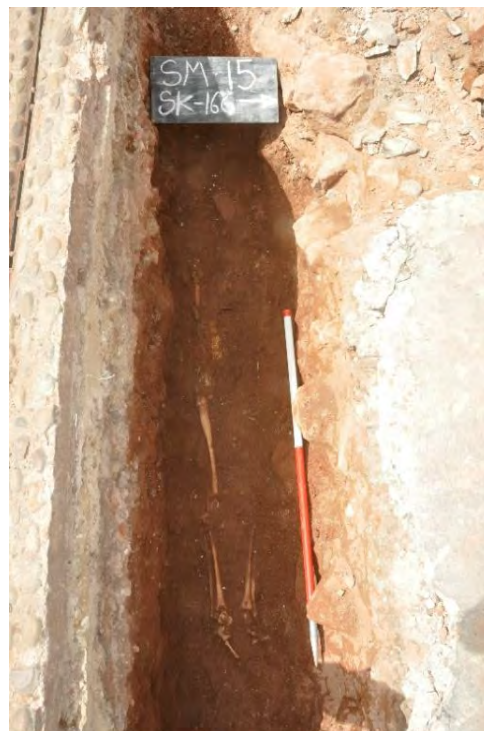
**Plate 8 (left).** Skeleton 163. Pillow stone just visible below skull. Wall 168 is visible top left. Wall 172 to right. View to west. **Plate 9 (right).** Skeleton 166. Wall 172 to right. View to west

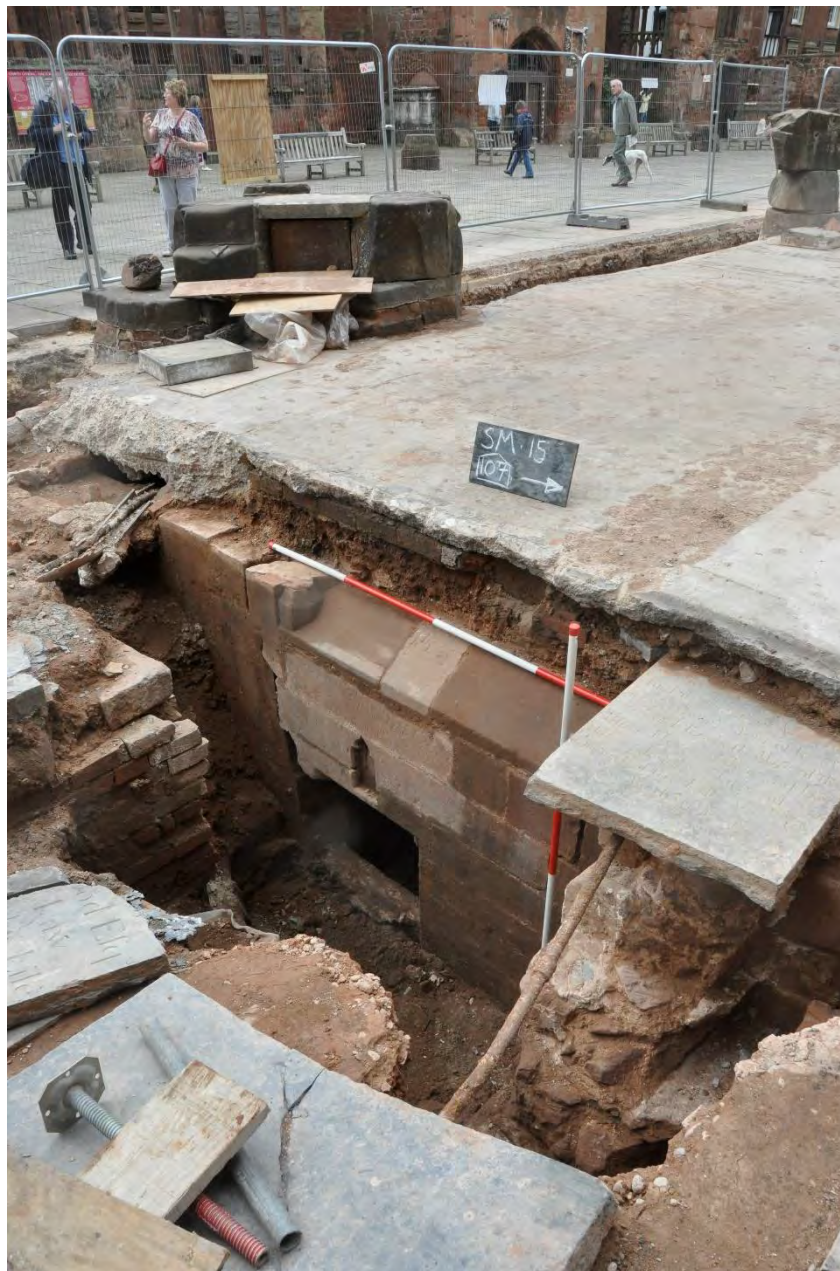
**Plate 10.** Wall 107. East elevation of the East Crypt. Crypt window, statue niche, buttress and bottom of the window cill for upper structure (chapel of All Saints) are visible. Pillar 103 in background, steps into crypt are just visible. View to SW.

the ashlar blocks face had broken. Also, on the eastern side of the window, the surface of three to four courses of the ashlar stonework had been damaged, although the cause of this was not evident.

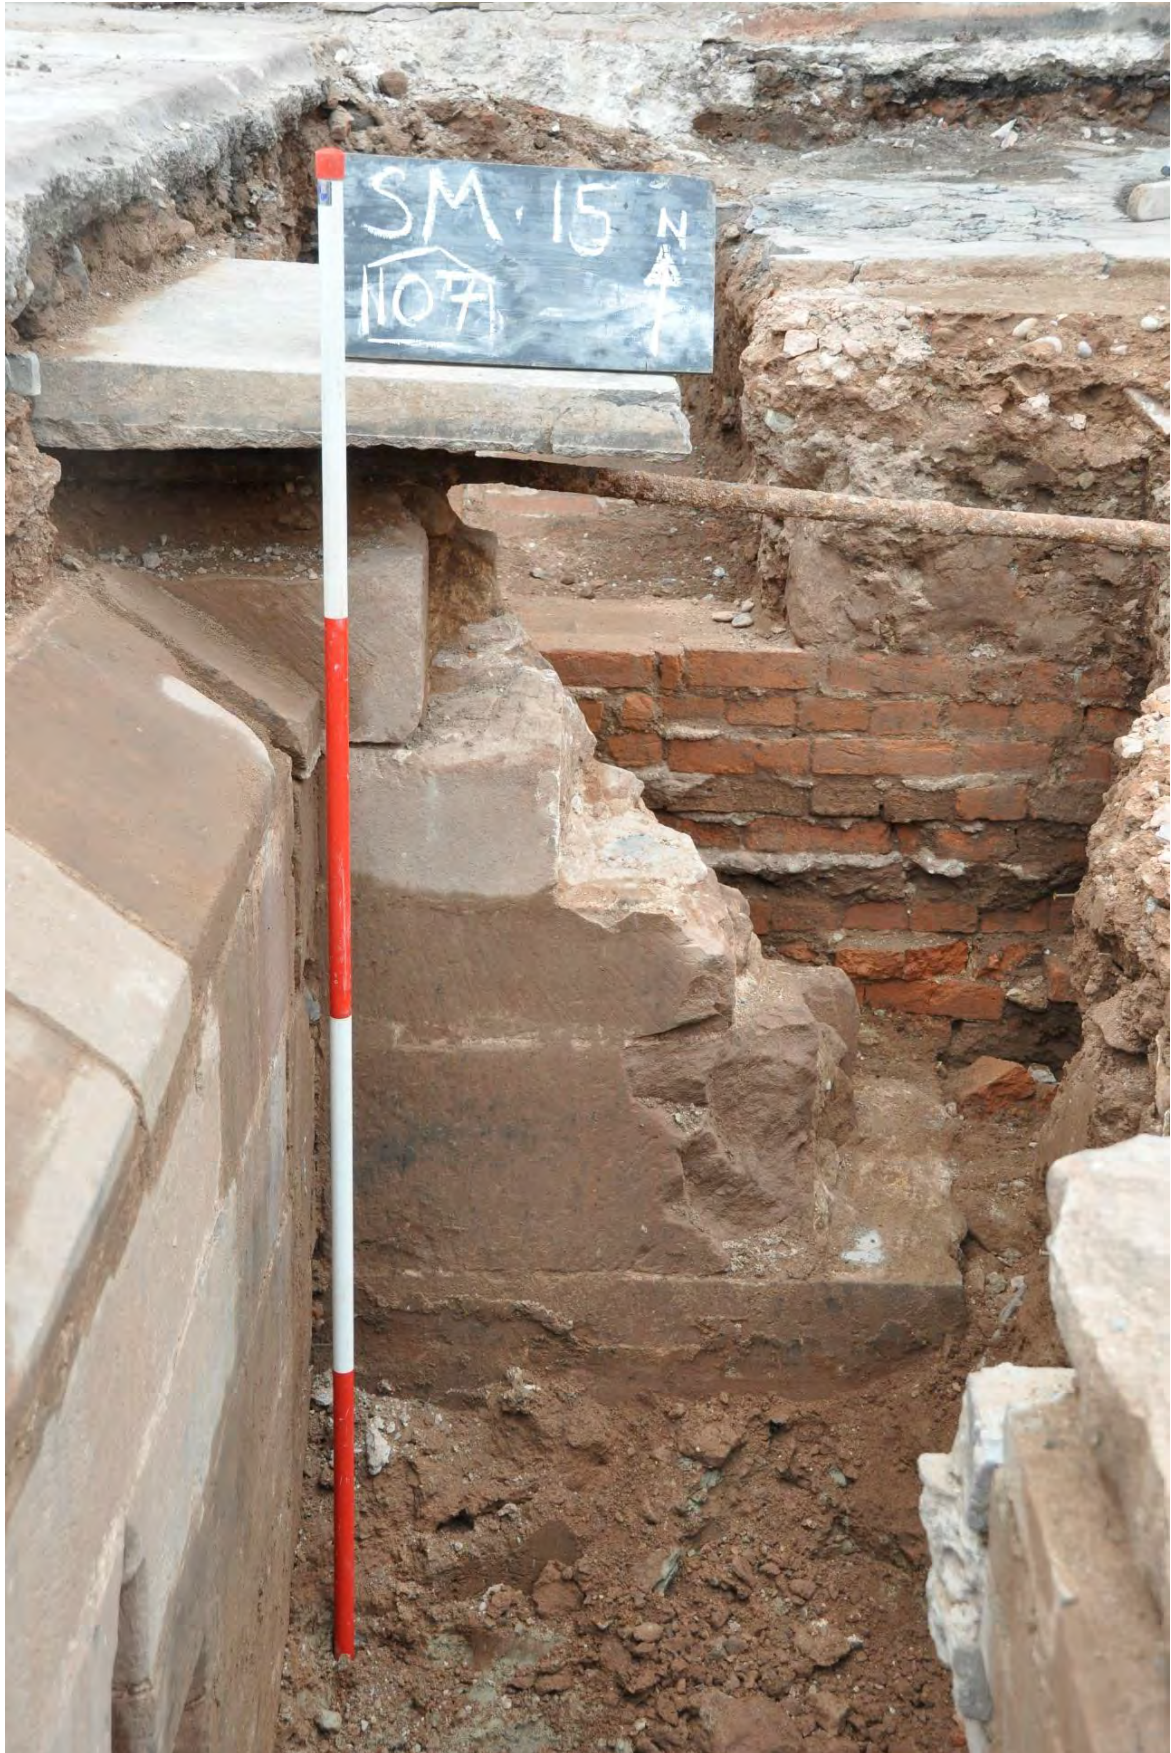
*Plate 11. Wall 107 buttress. Vault 156 visible behind buttress. Memorial stone No 21 above. View to north.*

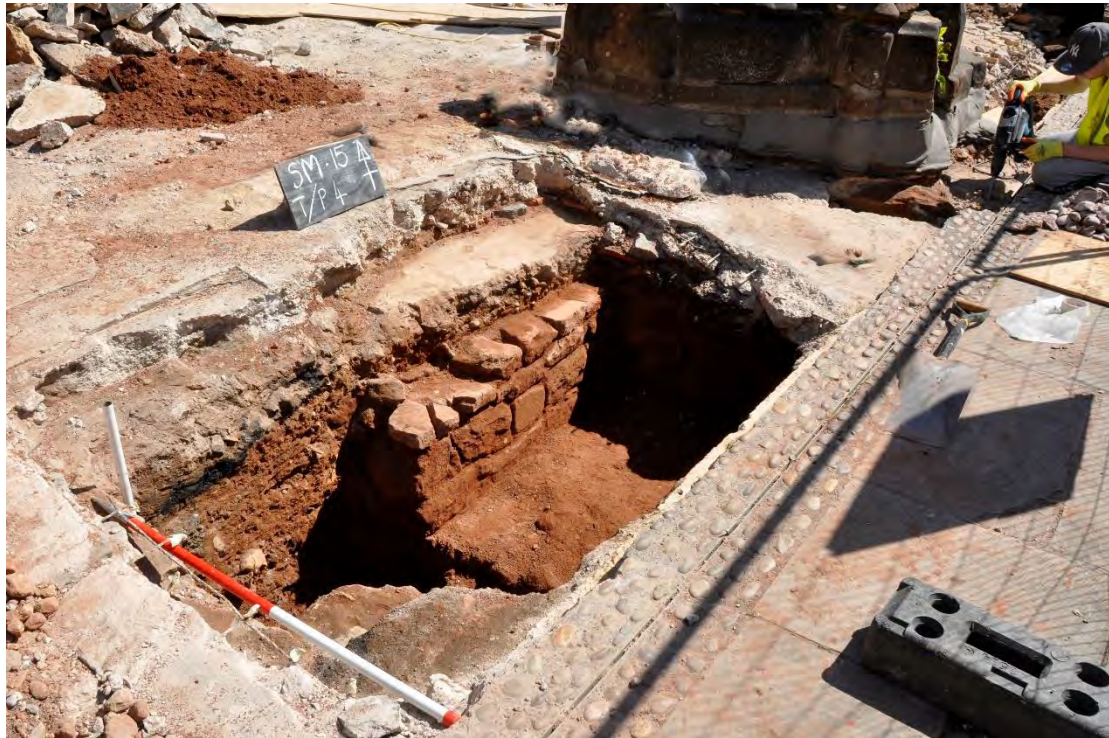
*Plate 12. Wall 235 (centre) cut by grave(s) 240 to west. Base of Pillar 103 (upper right) View to NE.*

A deposit (244) accumulated against the south face of Wall 235 appeared to represent a backfill associated with the construction of steps into the Wyley Crypt, although not confirmed within the confines of the excavation. Deposit 244 comprised moderately compact, dark reddish brown sandy silt with up to 35% sandstone rubble and 5% fragmented charnel, 0.9m in depth (as seen).

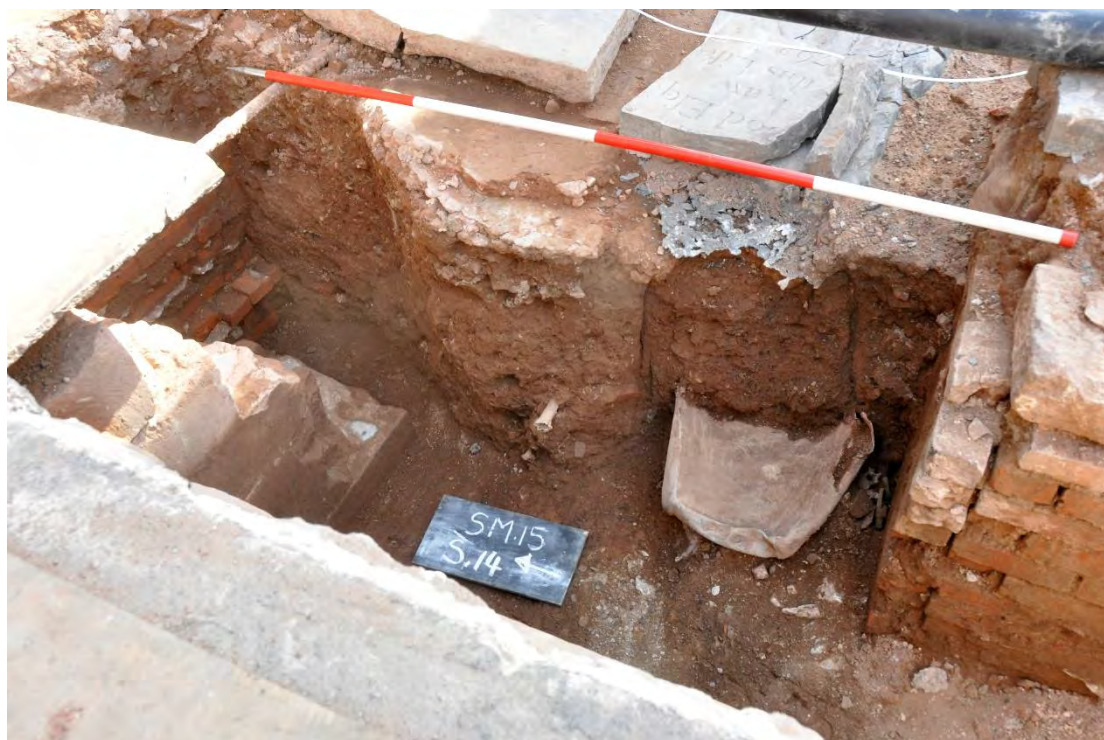
**Plate 13.** Section 15. Deposit 169 cut by Brick Vaults 155 (right) and 156 (just visible to left), and earth cut grave (151), containing lead coffin (170) and Memorial Stone No 20 (top).

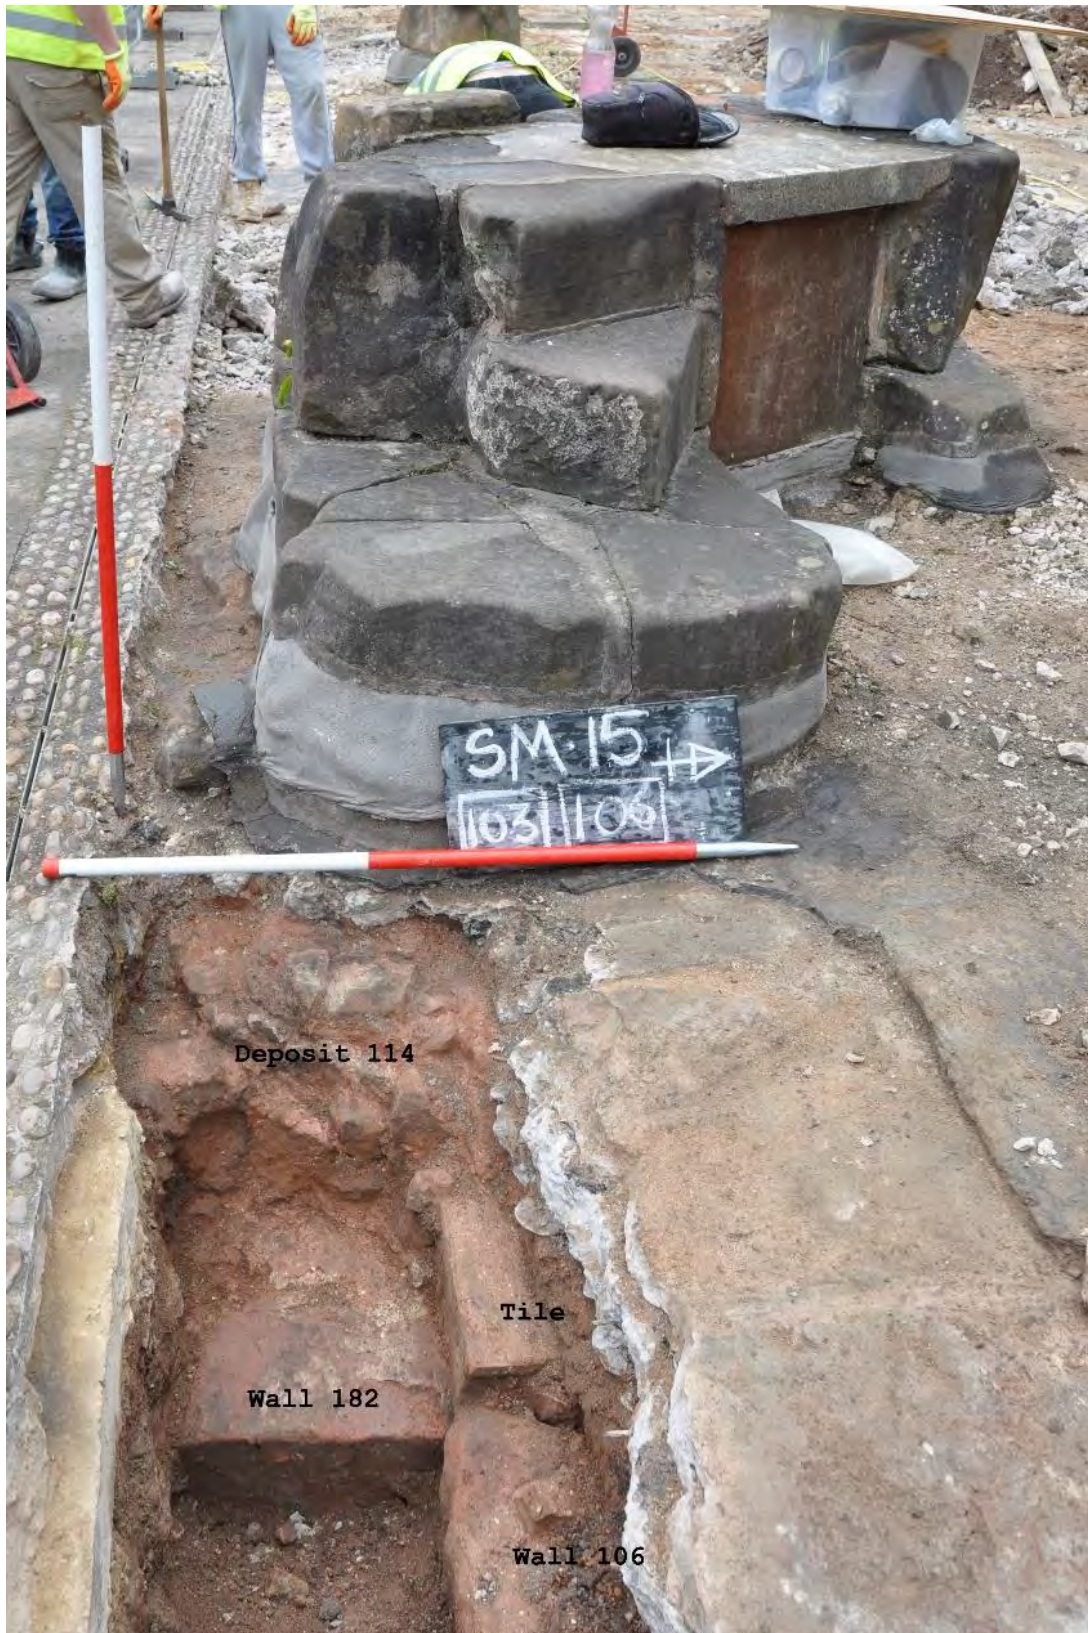
**Plate 14.** Steps/Pillar 103 (top middle) over foundation deposit 114. Boarded entrance to the East Crypt is visible on right side of pillar. Wall 182 abutted to east by Wall 106 (bottom middle) and retaining deposit 114. Concrete 101 to right. View to west.

which appeared to be retained to the east by Wall 182, therefore contemporary with the foundation deposit.

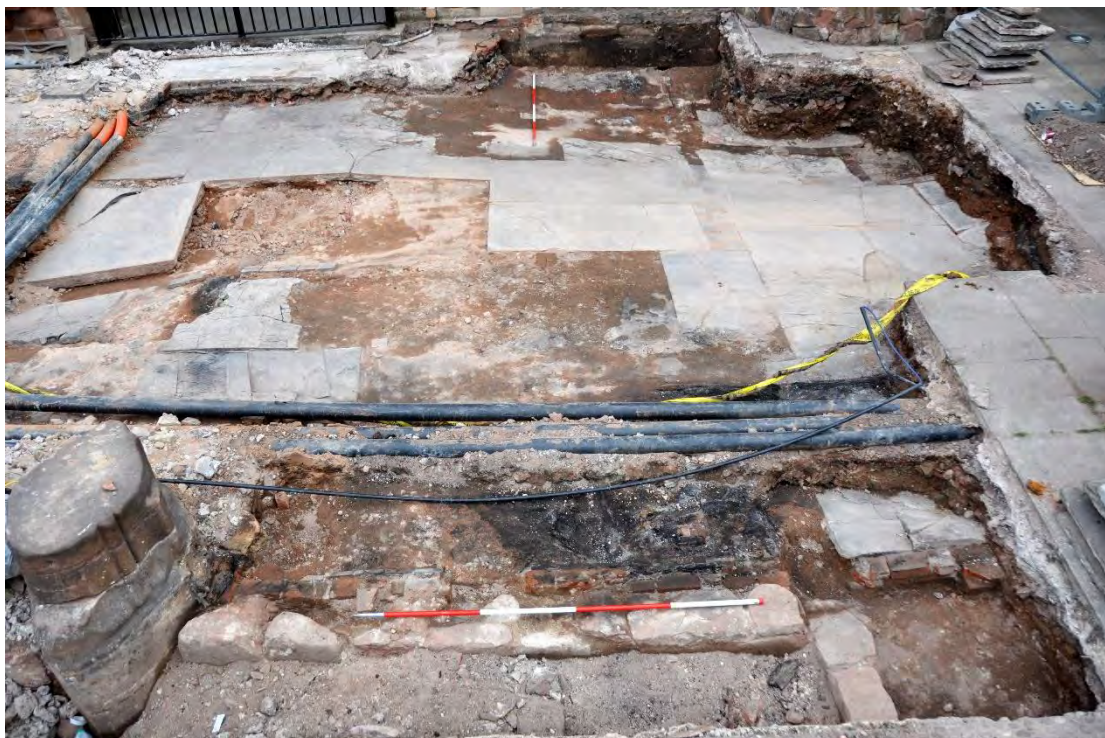
**Plate 15.** Memorial Stones at east end of excavation. Note the surface sloping down to north and east. Walls 141 and 142, bottom middle. Wall 145, bottom right. Grave 215, far top (right of scale), with putlog hole (223) just to its right (just visible). View to north.

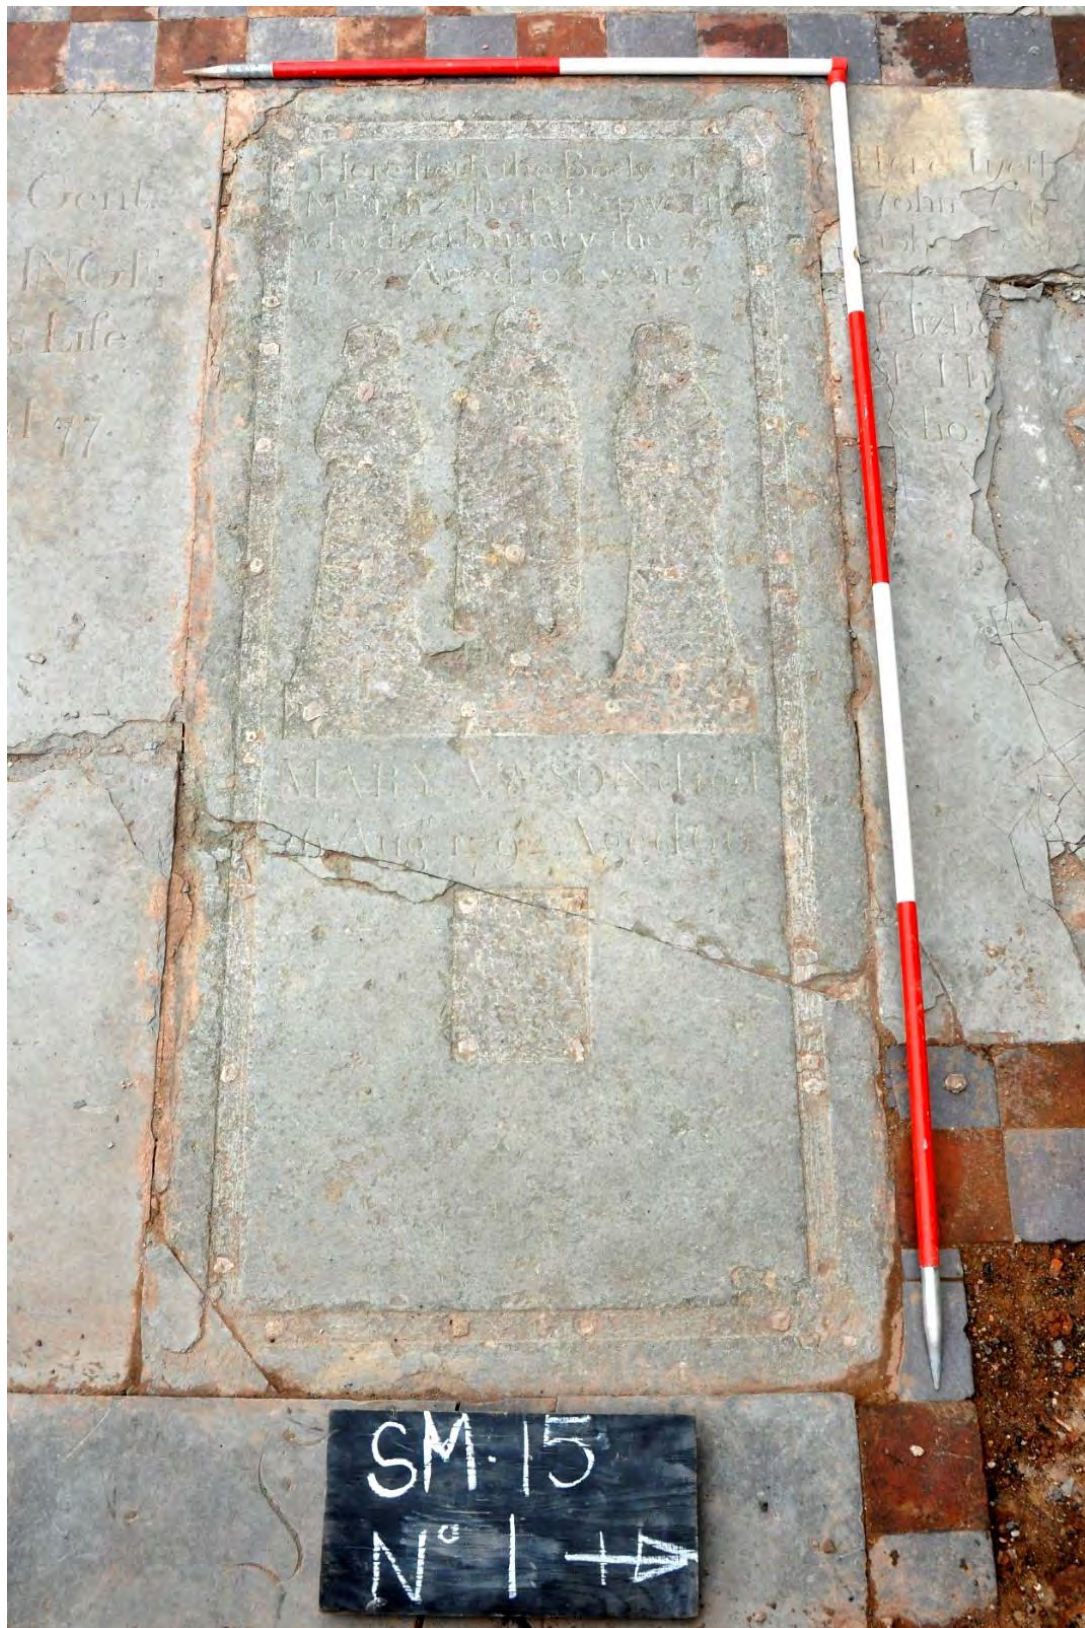
**Plate 16.** Memorial Stone (MS No 1) for Elizabeth Lapworth who died January 8<sup>th</sup> 1722, Aged 100 years, and Mary Awson who died 6<sup>th</sup> August 1792, aged 66. Note: missing brasses of three figures, boarder and plaque. Note; Victorian tiles (225) forming division between memorial stones (bottom right).

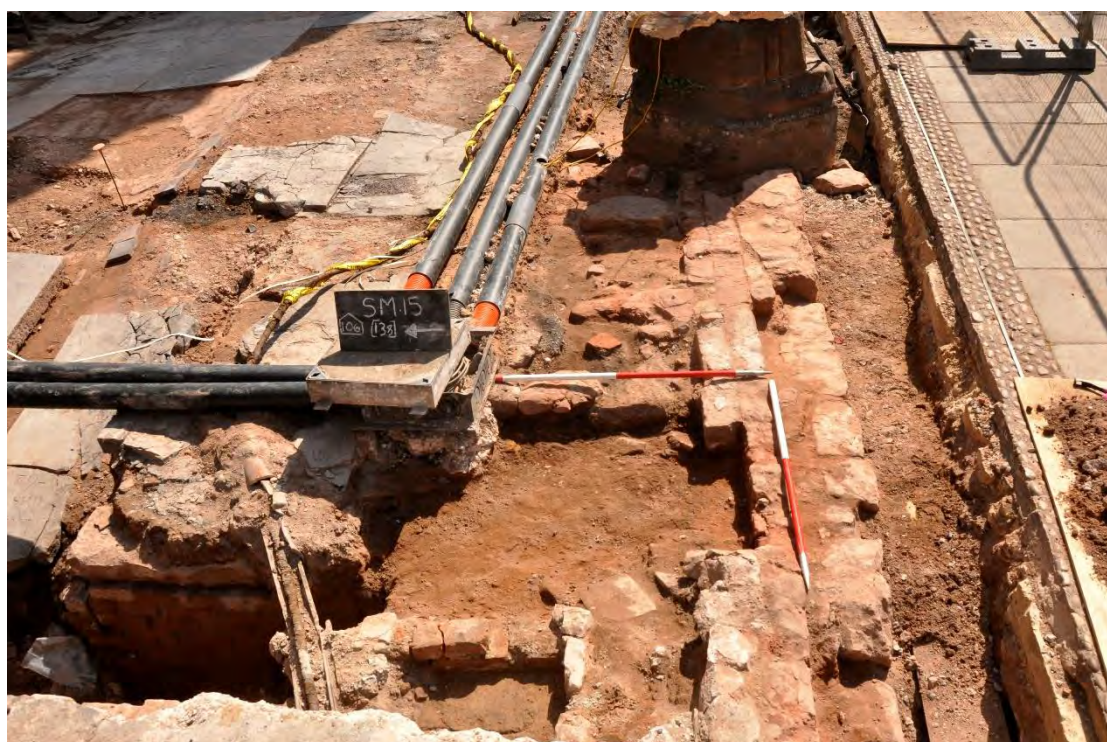
*Plate 17. Walls 106 and 139 to right. Wall 147 in middle (beneath modern pipes). Air raid shelter entrance (138) bottom centre. Brick Vault bottom left. View to east.*

Wall 147, aligned east-west, was one course wide (0.3m) and 3.7m long. The wall was only observed in plan. At its western extent it turns to the south where it abuts the north side of Wall 139 to form a rectangular structure to the west and north of Pillar 102. It was constructed from hewn, reddish brown sandstone (0.5m x 0.3m average) and bonded with a pale yellow brown sandy mortar.

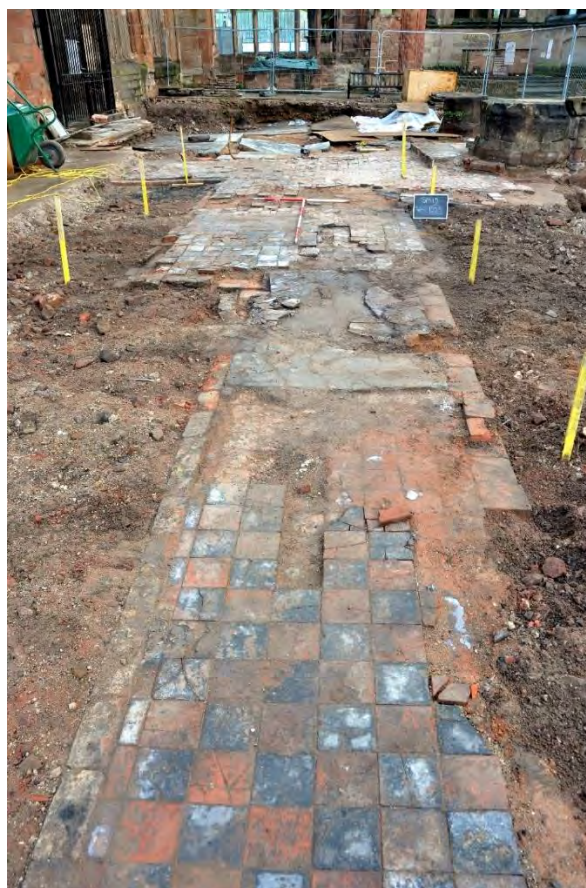
**Plate 18.** Tile floor 225, with edging bricks visible to left and medieval edging tiles on right. Note memorial stone (MS No 29, centre). Levelling deposit 226 visible on the far left and right.

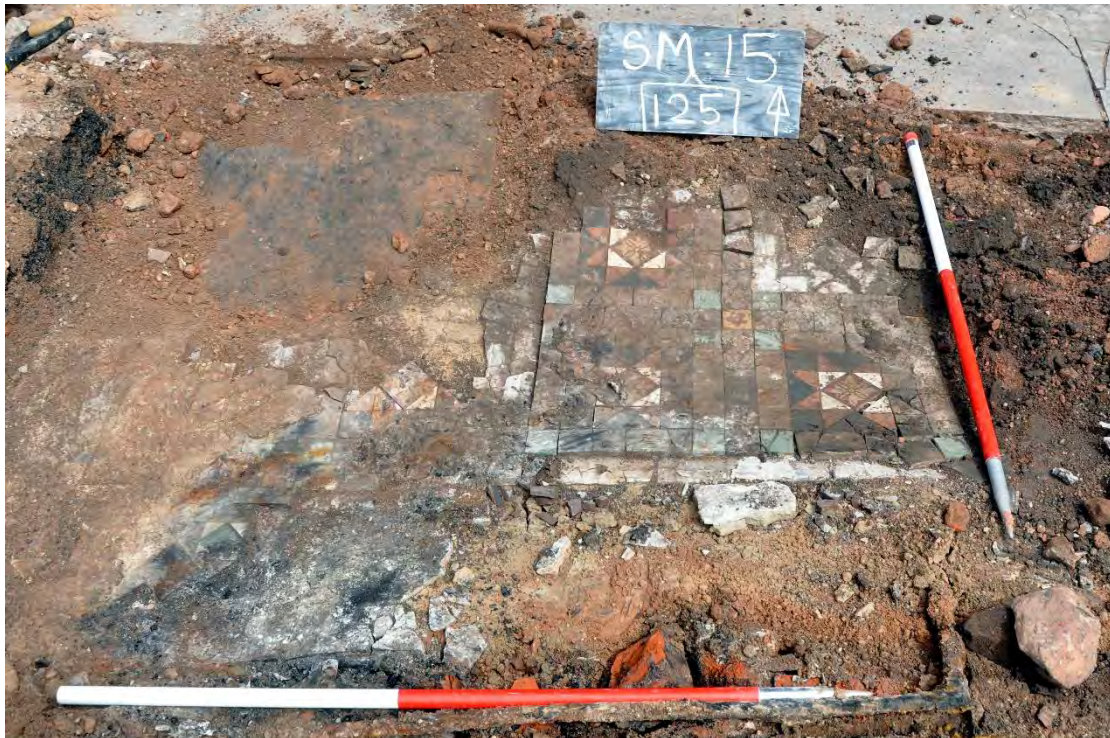
**Plate 19.** Tile floor 125. Note memorial stone (MS No 19) partially revealed (upper left) and iron gas pipe (foreground and extending beneath 125). Also note burning related to WWII bombing (bottom left). View to north.

The small area of repair, or surviving area of floor (125), was located directly over an area where a narrow iron (gas?) pipe had been inserted (150, Figs. 6, 7; Sect. 14; see also 5.4.2 *Victorian Tiles*), beneath a memorial stone (MS No 19), apparently causing some slumping/compression of deposit 149 (see 4.8.1 *Topography*). The slumping (or insertion) may have resulted in the breakage and slumping of Memorial Stone No 19 (Plate. 13). The floor was formed from square tiles in two sizes (0.54m x 0.54m x 0.12m and 0.73m x 0.73m x 0.12m), equilateral triangular tiles (0.54m x 0.54m x 0.12m). The triangular tiles were in two plain colours, drab orange and dark grey. The larger square tiles had a fleur de lis pattern in dark red and pale brown. The smaller square tiles were largely plain, in pale green and brown with a small number having a rosette pattern. A small area (c. 0.5m x 0.5m) of the floors surface had evidence of ash and lead clearly associated with the collapse of the roof following the bombing raid in 1940 (see 4.10). Five of the decorated floor tiles found at Old St Michael's clearly show the full maker's mark (*Minton Hollins & Co Patent Tile Works Stoke on Trent*) on the back identifying Minton as the manufacturer, formed in 1845.

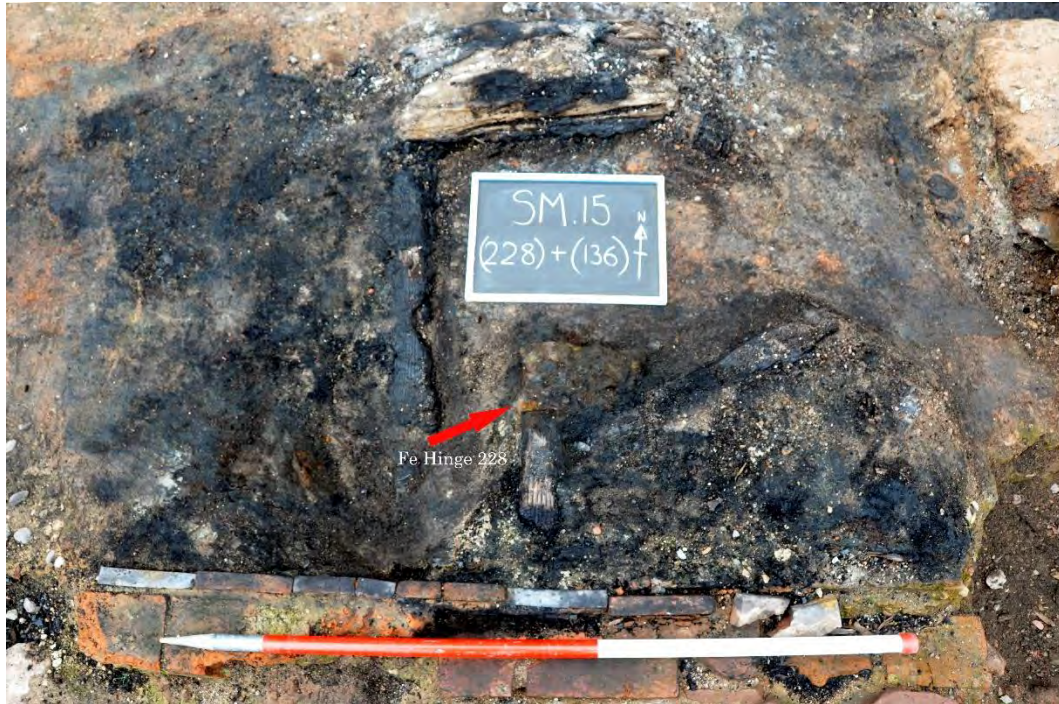
*Plate 20. Deposit 136 with wooden structural elements. View to north.*

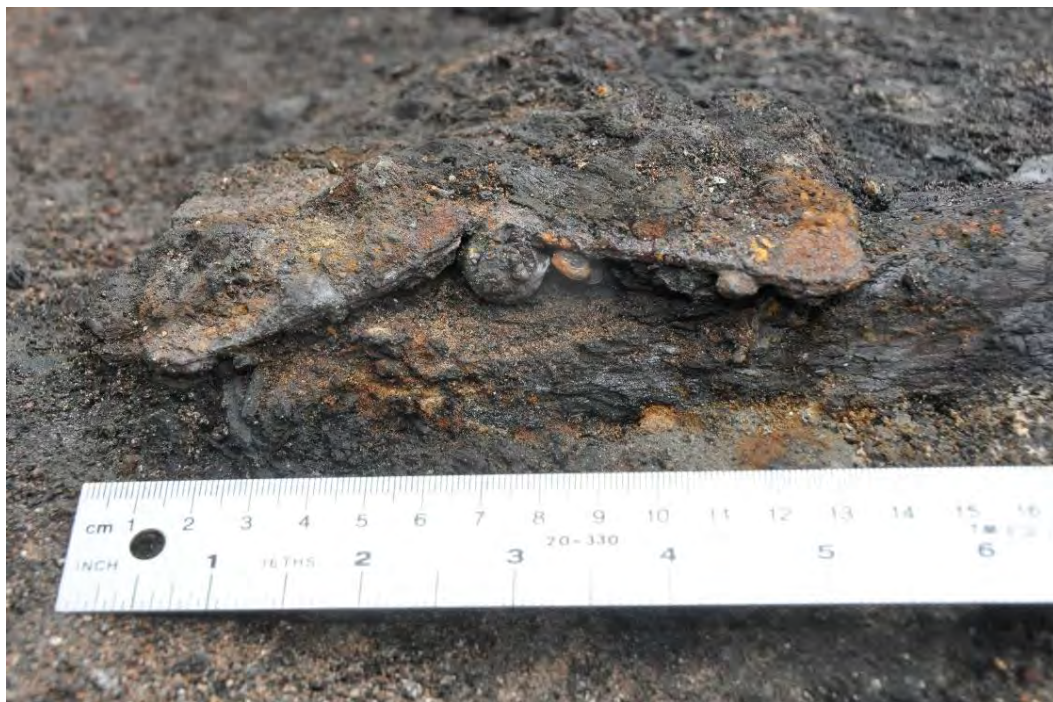
*Plate 21. Detail of iron hinge 228 attached to wooden structural element within deposit 136.  
View to east*

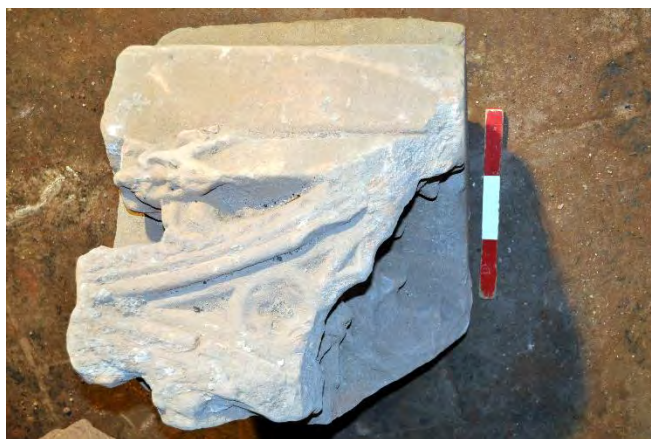
*Plate 22. Worked Stone No 1.*

Dimensions: 490mm x 450mm x 410mm. Material: sandstone. Description: part of a stone canopy of a tomb or stall. There is a carved vault with five ribs and a central boss. The top of a round headed arch below the canopy has an internal cinquefoil design. The upper part of the canopy design contains a moulding around a slender pointed arch, which contains a roundel containing a quatrefoil. Crockets are a feature of Gothic features, most notably capitals, spires, canopies and pinnacles (Verey and Brooks 1999, 773). Their design developed throughout the Gothic period. Though this particular piece was undoubtedly for an internal canopy there are similarities in the architecture here to features that were constructed as part of the decoration of the tower that was constructed c 1350-c 1390 (Demidowicz and Gilderdale Scott 2015, 31-32, 36).
