**OLD ST MICHAEL'S CATHEDRAL,  
ST MICHAEL'S AVENUE, COVENTRY**

**ARCHAEOLOGICAL MONITORING AND  
INVESTIGATION REPORT**

**FEBRUARY 2016**

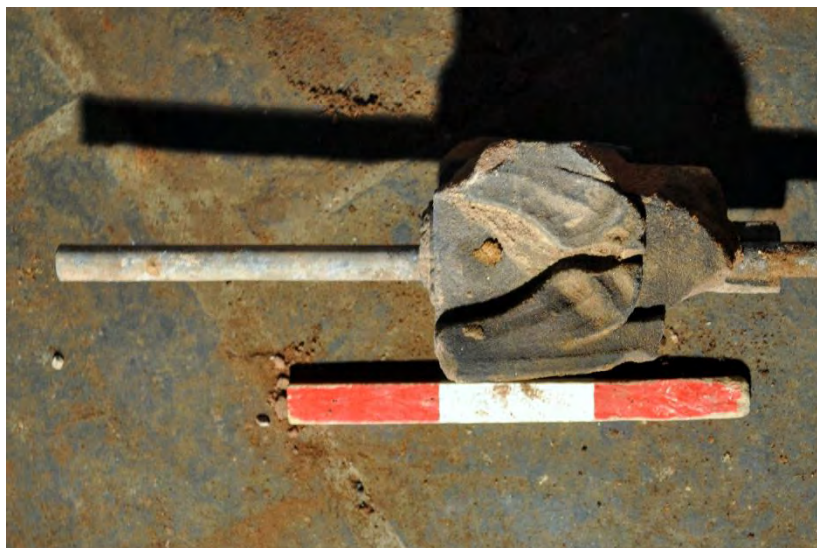
*Plate 23. Worked Stone No 22.*

Dimensions: 390mm x 240mm x 235mm. Material: sandstone. Description: the moulding has a roll flanked by an angle fillet followed by an ogee wave then a further angle fillet; with a further ogee and an angle fillet. The latest feature recognised here is

the ogee, which is a late Gothic development in England (Morris 1992, 13). This detail usually occurs on continuous mouldings for arches. There are similarities with WS14.

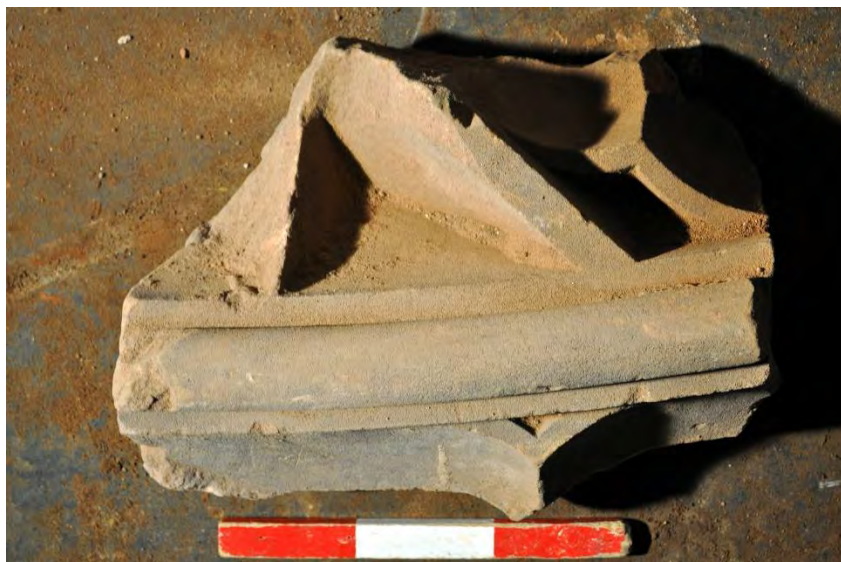
*Plate 24. Worked Stone No 32.*

Dimensions: 330mm x 280mm x 180mm. Material: sandstone. Description: a triple roll design but with angle fillets inserted between the semi-circular rolls. The triple roll development is associated with Gothic from the 13<sup>th</sup> century (Morris 1992, 9).

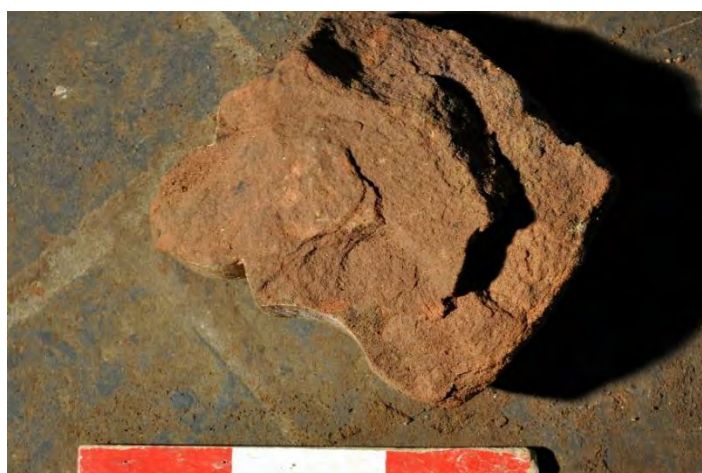
*Plate 25. Worked Stone No 35.*

Dimensions: 290mm x 250mm x 120mm. Material: sandstone. Description: a roll with fillet, which is flanked by two angle fillets and parts of further ogee mouldings that only partially survive. The ogee moulding is the latest feature here and is associated with later Gothic styles of the 13<sup>th</sup> to 15<sup>th</sup> centuries (Morris 1992, 13).

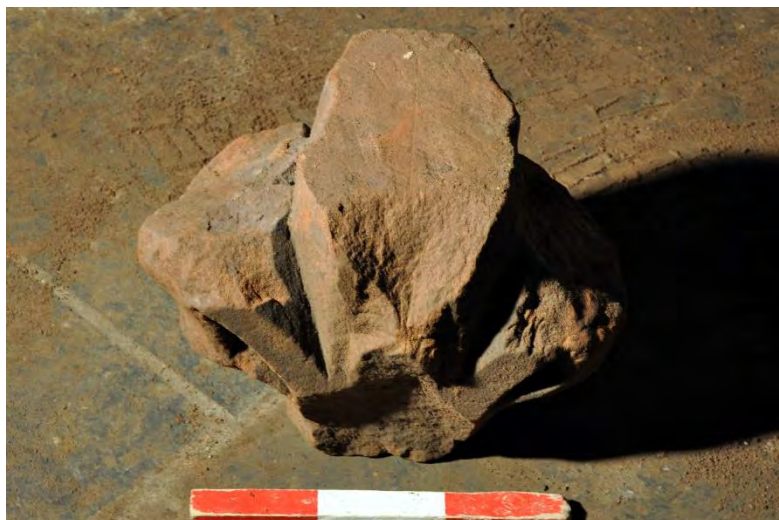
*Plate 26. Worked Stone No 42.*

Dimensions: 340mm x 260mm x 250mm. Material: sandstone. Description: part of a tracery moulding located at an arch springing or trifurcation point. The moulding uses broad freestanding fillets associated with hollow chamfers, some of which are associated with cusps. The freestanding fillet is a feature of the later Gothic (Morris 1992, 13) period and so this stone should be placed with a date range from the later 13<sup>th</sup> century to the 15<sup>th</sup> century. The moulding could come from the tracery of Saint Michael's Perpendicular windows c 1390-c 1450.

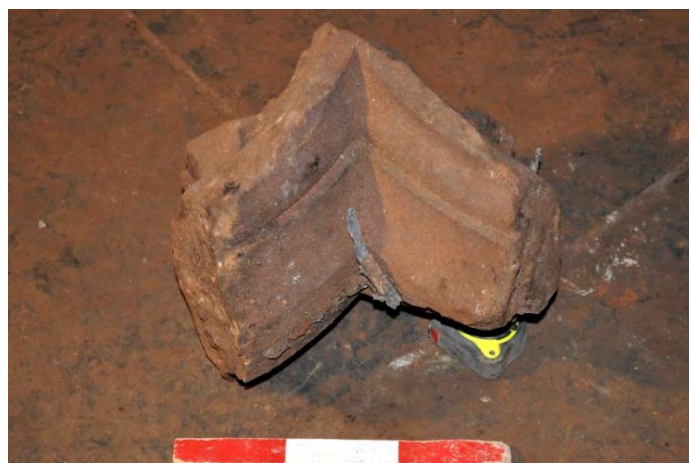
**Plate 27.** *Worked Stone No 58.*

Dimensions: 310mm x 300mm x 230mm. Material: sandstone. Description: a piece of window tracery with a freestanding fillet flanked by a hollow chamfer. The freestanding fillet is a feature of later Gothic so a date from the very end of the 13<sup>th</sup> century is possible although a 14<sup>th</sup> century date is more likely (Morris 1978, 46-49; Morris 1992, 13). There are also file-rolls used on one side of the tracery associated with an angle fillet. The stone also contains the remains of cusps. The feature is part of an English Decorated window tracery.

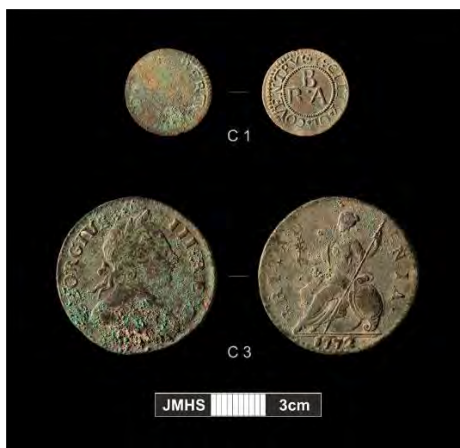
**Plate 28 - Token 1 (C1).** 17<sup>th</sup> century Coventry token issued by Robert Bedford. **Coin 2 (C2).** halfpenny of William III, broadly dated from 1695 to 1701.

The earliest dated coin is 17<sup>th</sup> century Coventry token issued by Robert Bedford (Plate 28). This token has not been listed as a known type (Dickinson M. 1986, p219).

This is a halfpenny of William III (Plate 28), broadly dated from 1695 to 1701.
