JOHN MOORE HERITAGE SERVICES

ARCHAEOLOGICAL WATCHING BRIEF

MONGEWELL PARK,

MONGEWELL, OXFORDSHIRE

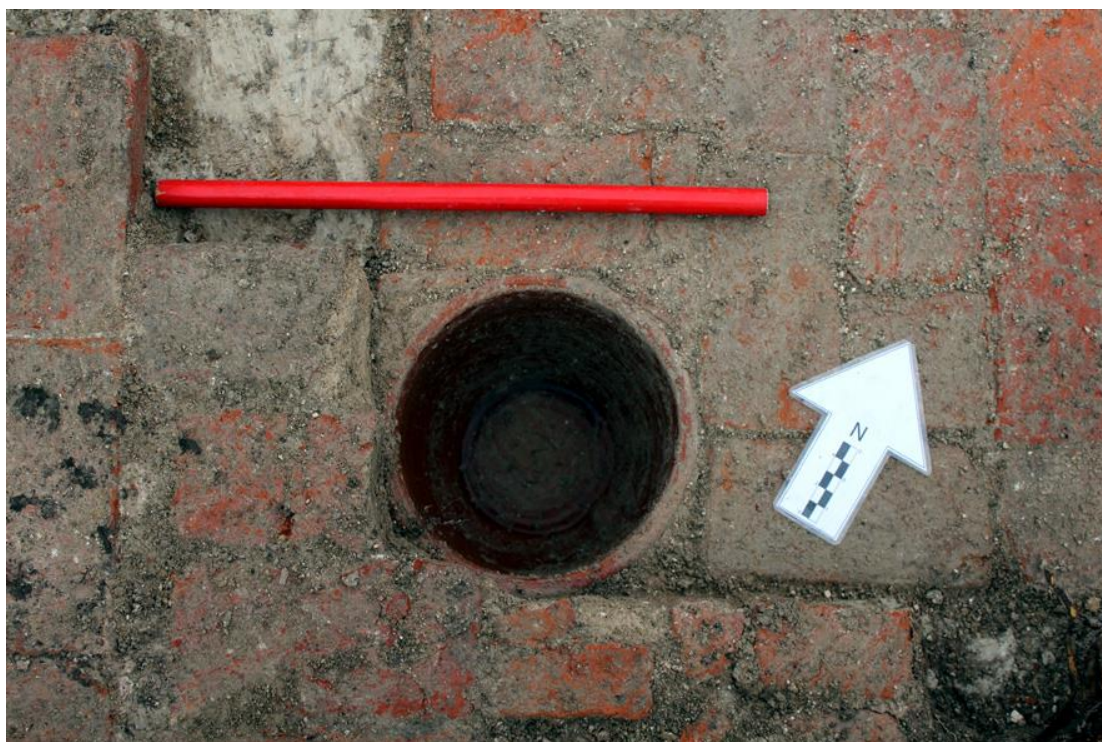
Plate 1: Earthenware vessel set into floor 41. 0.5m scale.

To the west of fireplace **44** were brick floors **41**, **42** and **11**. These floors appeared to belong to a separate room than that of floor **43** that was demarcated by the difference in brick bond and location to the west of the fireplace. Floor **41** was located immediately behind fireplace **44**; this floor measured >1.5m in length and 1.5m in width; it was bedded on a compact light yellowish grey mortar (164) which overlay a levelling/bedding deposit of firm light grey silty clay 0.1m in thickness (165). The bricks were set in a stretcher bond and an earthenware vessel with a diameter of 220mm and a depth of 250mm had been set into the south western corner of the floor, with the rim of the vessel set at floor level (Plate 1).

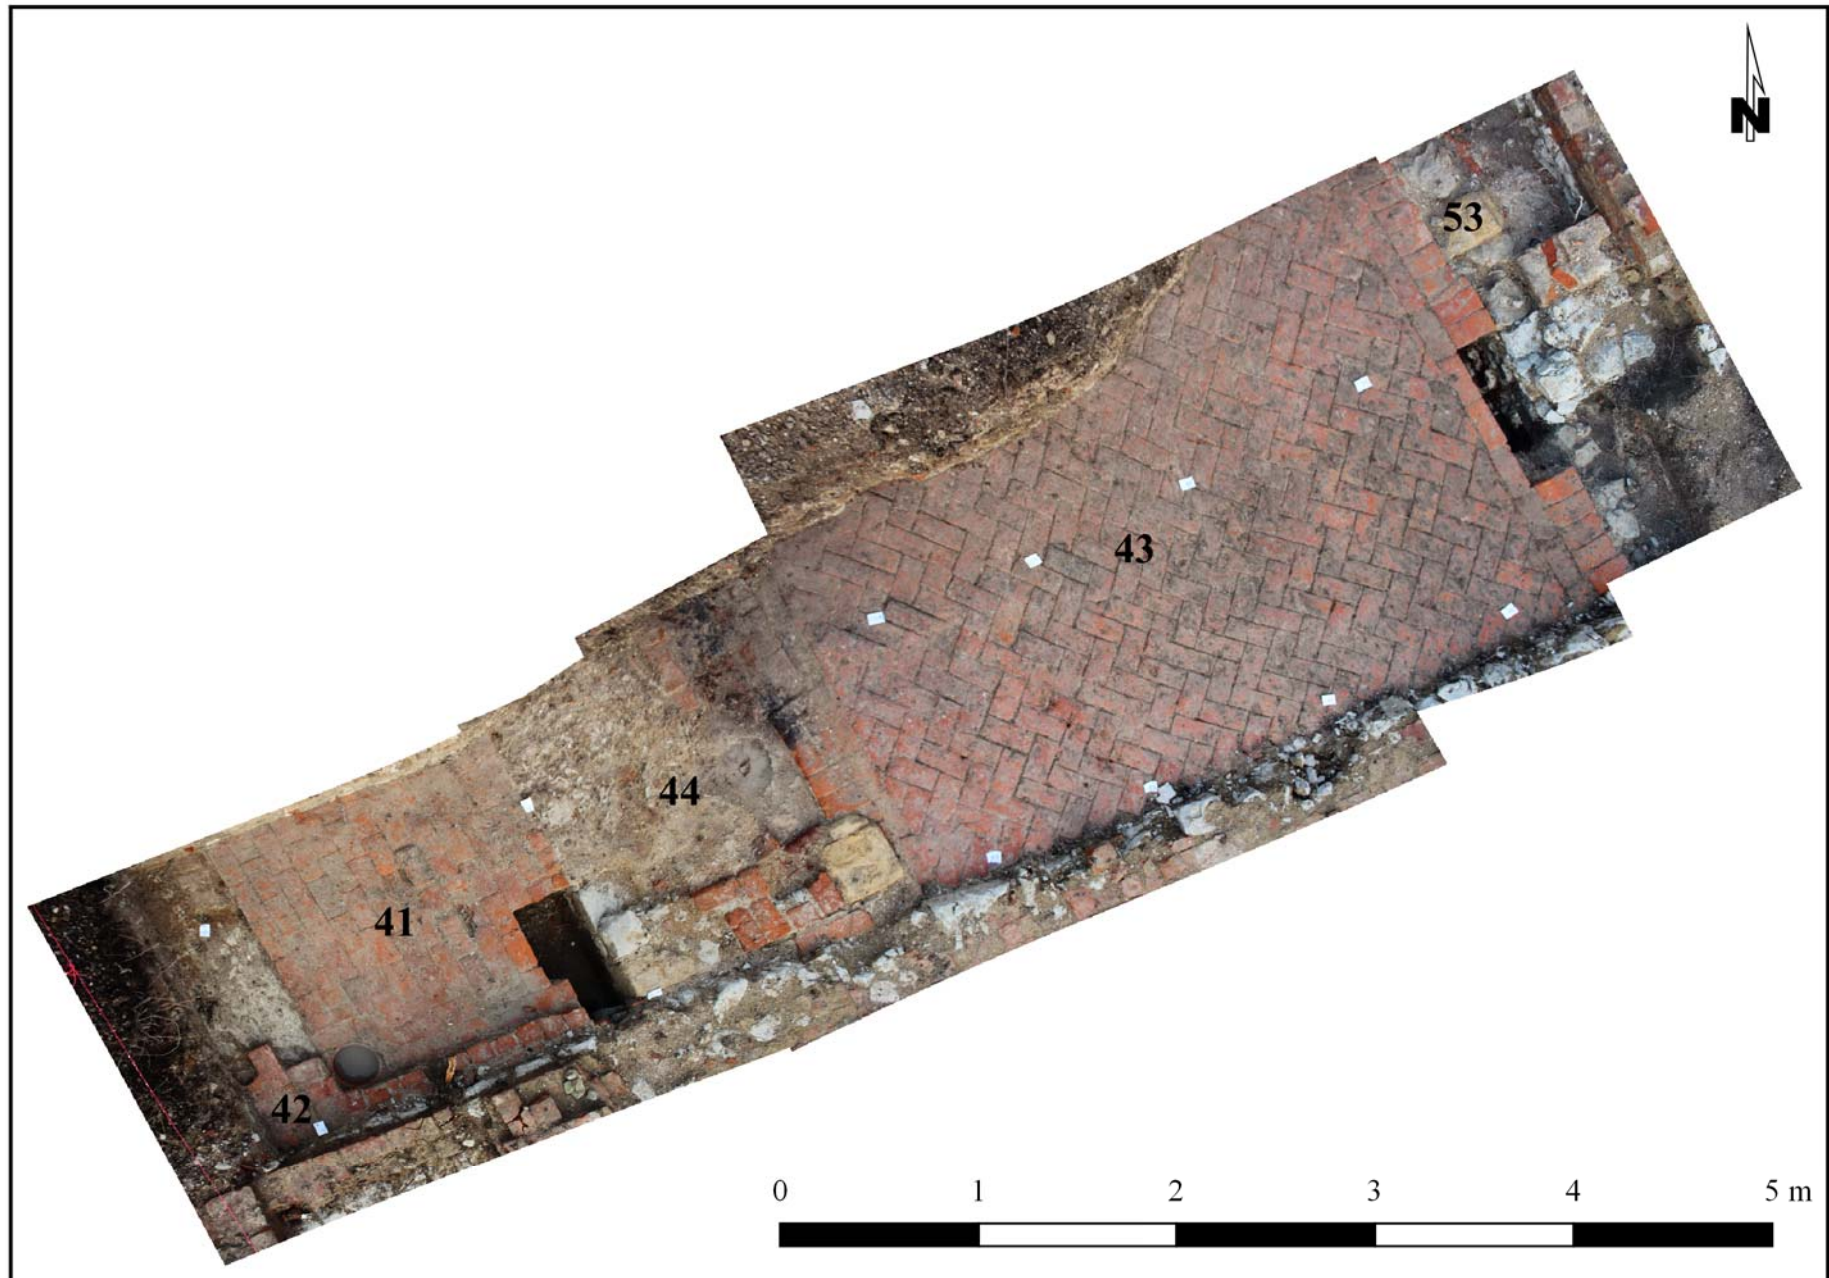
Figure 3: Floors and hearth associated with phase 1.

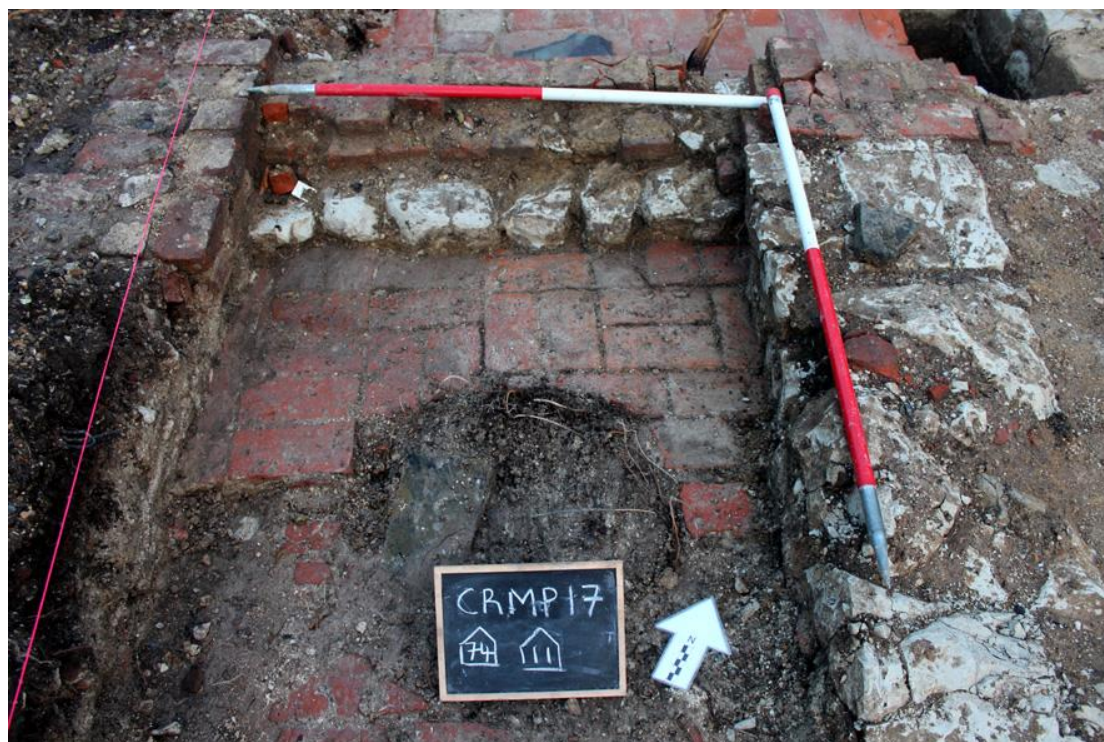
Plate 2: Floor **11** overlain by wall foundations **13** and **74**.

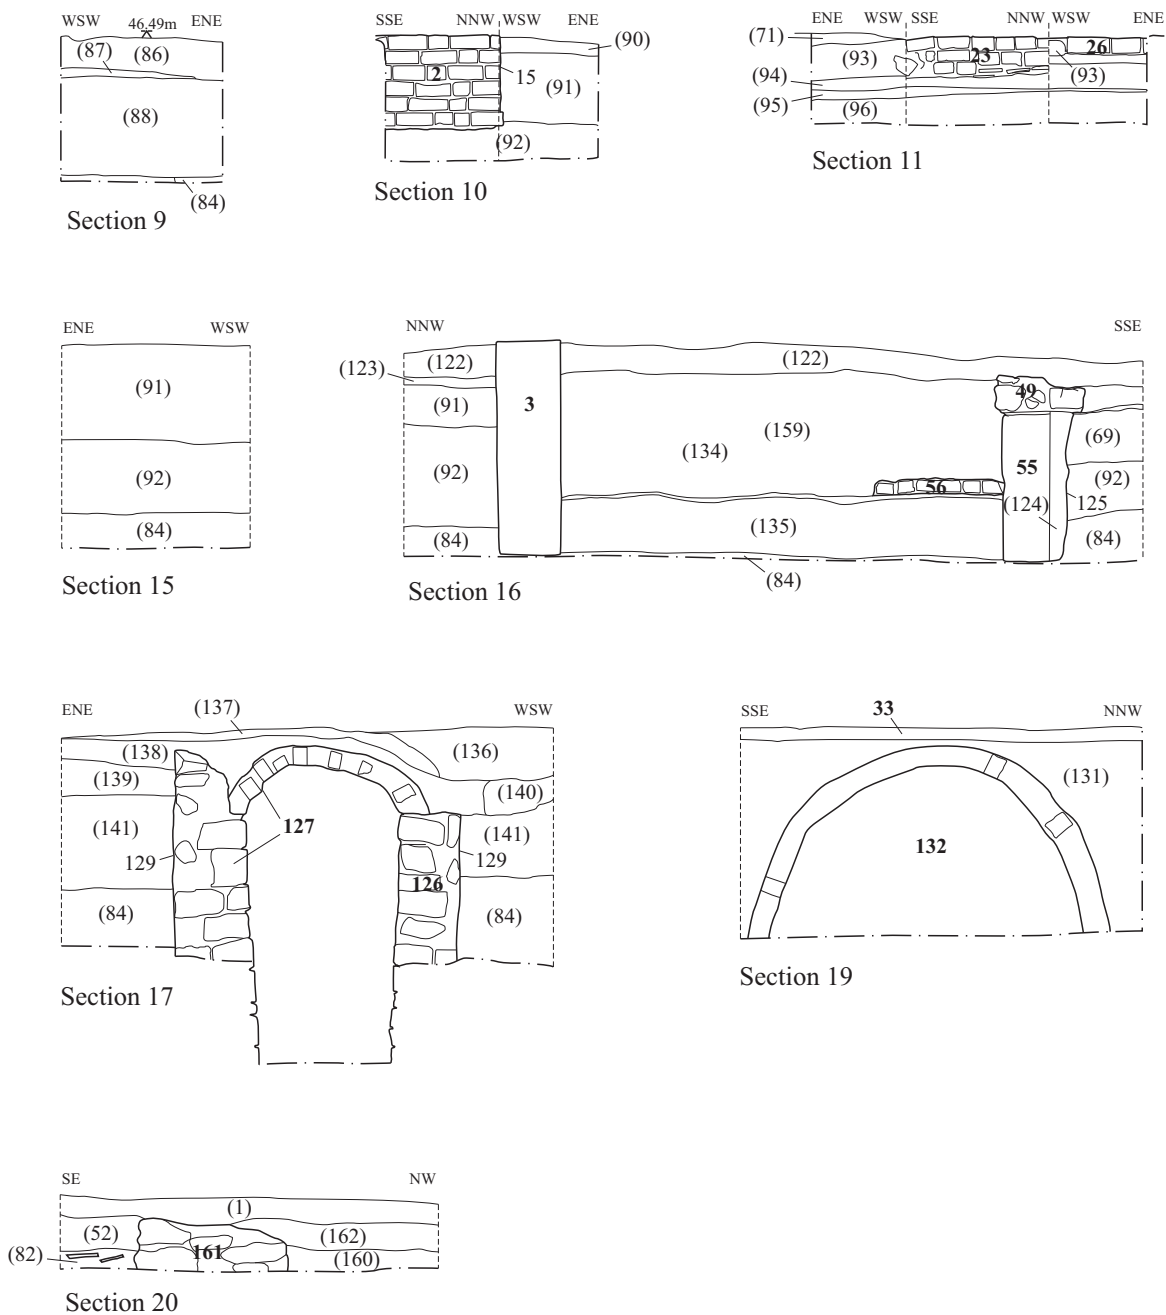
Figure 6: Sections associated with phases 3 and 4.
13

The cellar floor was found to be intact; **57** measured 2.2m by >1.0m within the trench and was also of brick, set in a stretcher bond. An additional brick built structure, recorded as **56**, was present which appeared to represent the remains of a staircase leading into the cellar, although this had been truncated during demolition (Fig. 5: Section 5). To the south of wall **3** the wing extended for a further 4m, before turning west to form the presumed gable end. The area bounded by walls **02** and **03** contained a thin layer of compact mid yellowish brown silty sand 0.06m in thickness; this was interpreted as the truncated bedding layer for a floor removed during demolition (Fig 6: Section 16).

Located to the east of the main structure was a brick soakaway **132**, linked to the possible kitchen or utility room via a brick built drain **162** (Fig. 6: Section 19; Fig. 7). **132** was built from bricks measuring 220mm x 110mm x 75mm set in a stretcher bond; these were built into a beehive shaped structure measuring 1.7m in diameter with a depth of >1.0m, extending below the l.o.e. Drain **162** entered on the north west side. Where **162** was encountered in the footings trench it was 0.5m in height, 0.5m in width and built from the same brick as **132**. This structure ran for at least 2.5m, extending beyond the l.o.e. to the north west. The orientation suggested that it was running toward the north eastern corner of the building, where wall **25** butted cellar wall **19**; this is not certain however as the structure extended beyond the l.o.e. Both were built within construction cut 132, which followed the dimensions of the structures closely; this truncated cultivation soil (64). Fill (131) overlay the structures within the construction cut; this was a soft dark greyish brown silty clay with a thickness of at least 1.0m, extending below the l.o.e. This deposit was overlain by exterior cobbled surface **33**.

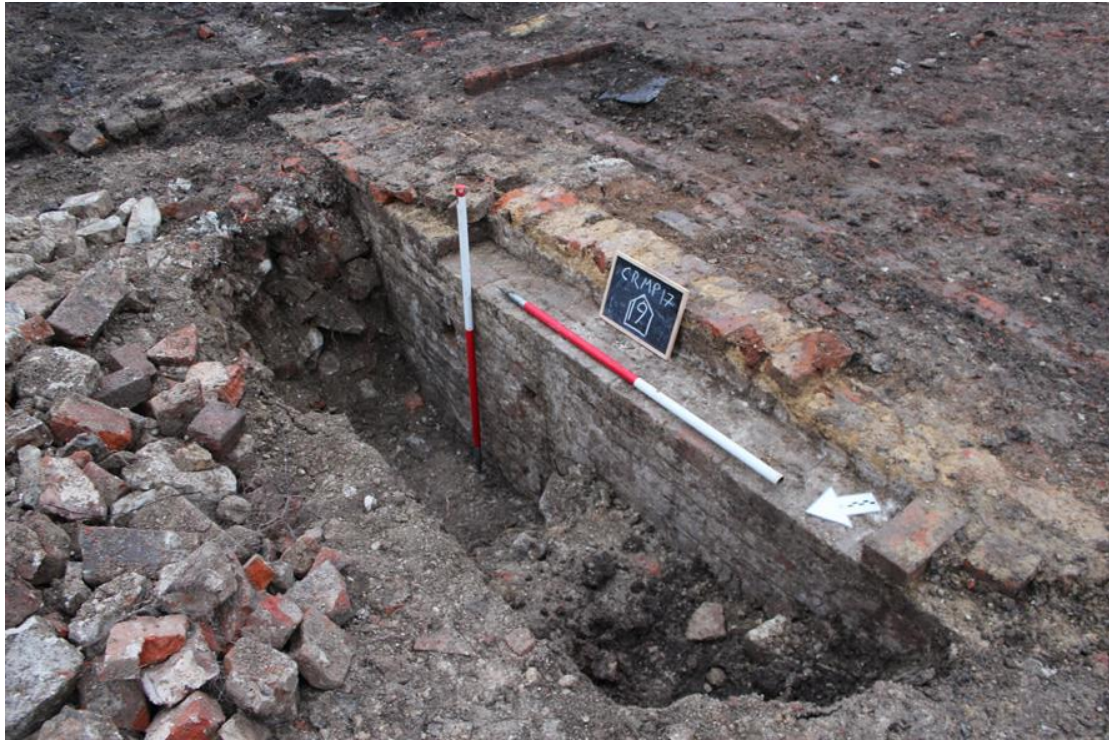
Plate 3: Southern cellar wall, showing whitewashed brick.

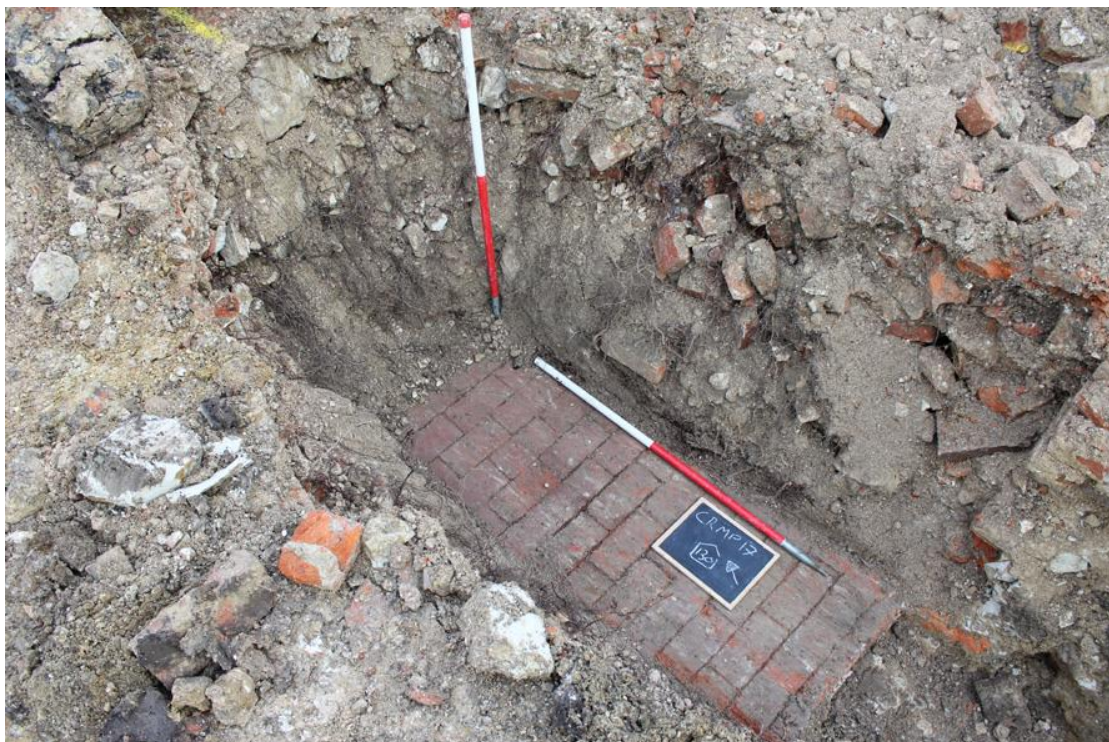
Plate 4: Cellar floor seen during excavation of footings trench.

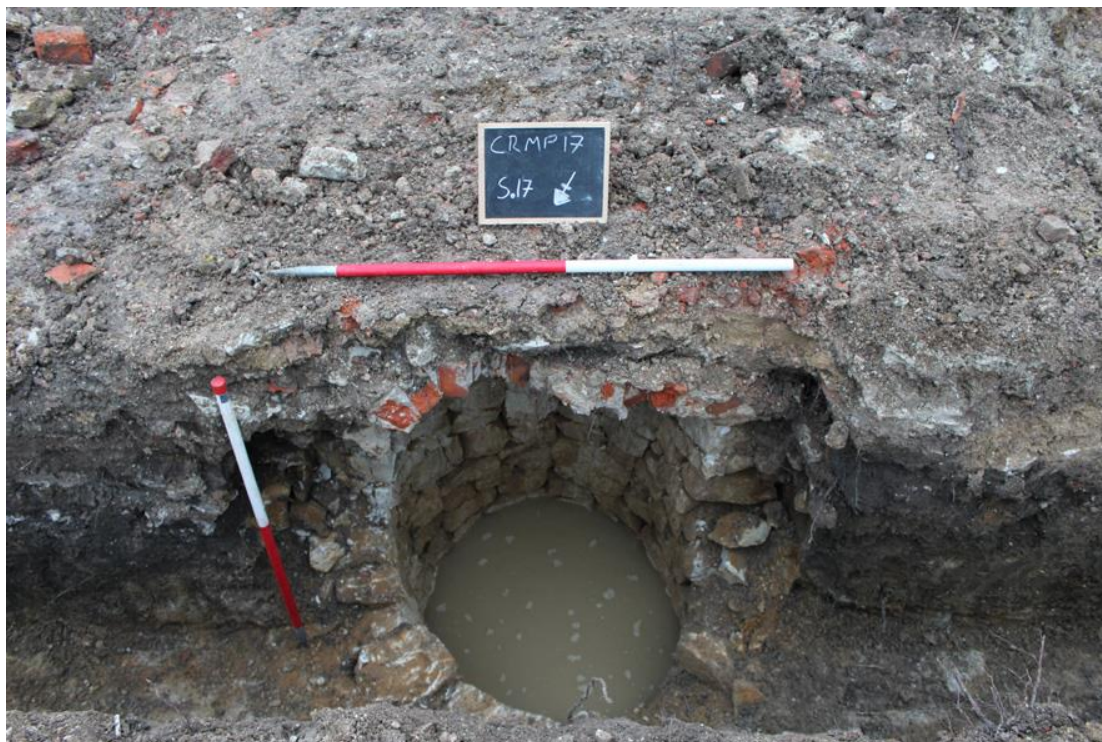
Plate 5: Chalk well **126**, seen during excavation of footings trench. Brick capping associated with Phase 4 is also evident.

A chalk built well, **126**, belongs to this phase (Plate 5). Due to the lack of stratigraphic relationships between the well and earlier phases of development, at best the well can be said to pre-date phase 4, and to post-date cultivation soil (64). Well **126** was built within construction cut 129 that truncated garden soil (64) – here recorded as (141). Within the trench **126** measured 1.5m in diameter, with an internal diameter of 0.95m, and >1.6m in depth, extending below the l.o.e (Fig. 6: Section 17; Fig. 7). It was built from squared chalk blocks measuring 300mm x 250mm x 200mm (average). The faces of these blocks had been carved to be slightly concave and they were set in random courses.

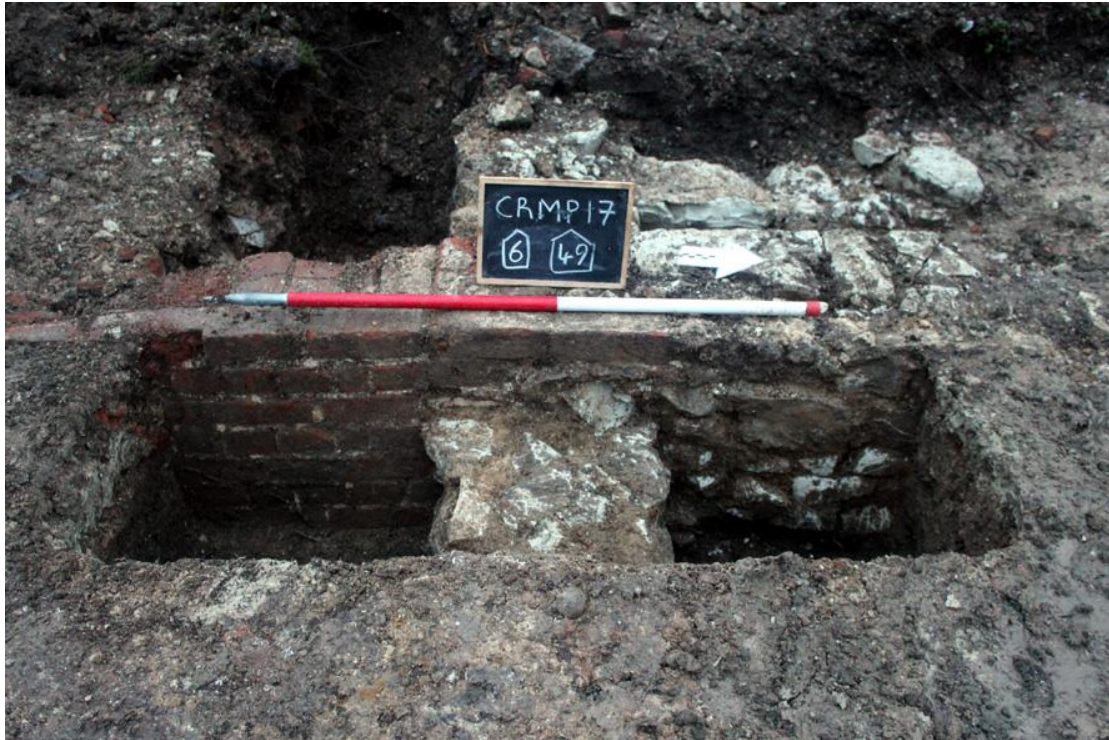
Plate 6: Brick built extension **2** keyed into chalk wall **74**.

The north west-south east wing of the previous phase was extended to the south: wall **02** was butted against the southern end of **74**, running for a length of 6.5m before turning west to form the end of the extension (Fig. 5: Section 12; Fig. 6: Section 10. Plate 6). This wall was built within construction cut 15. A half-cellar was inserted

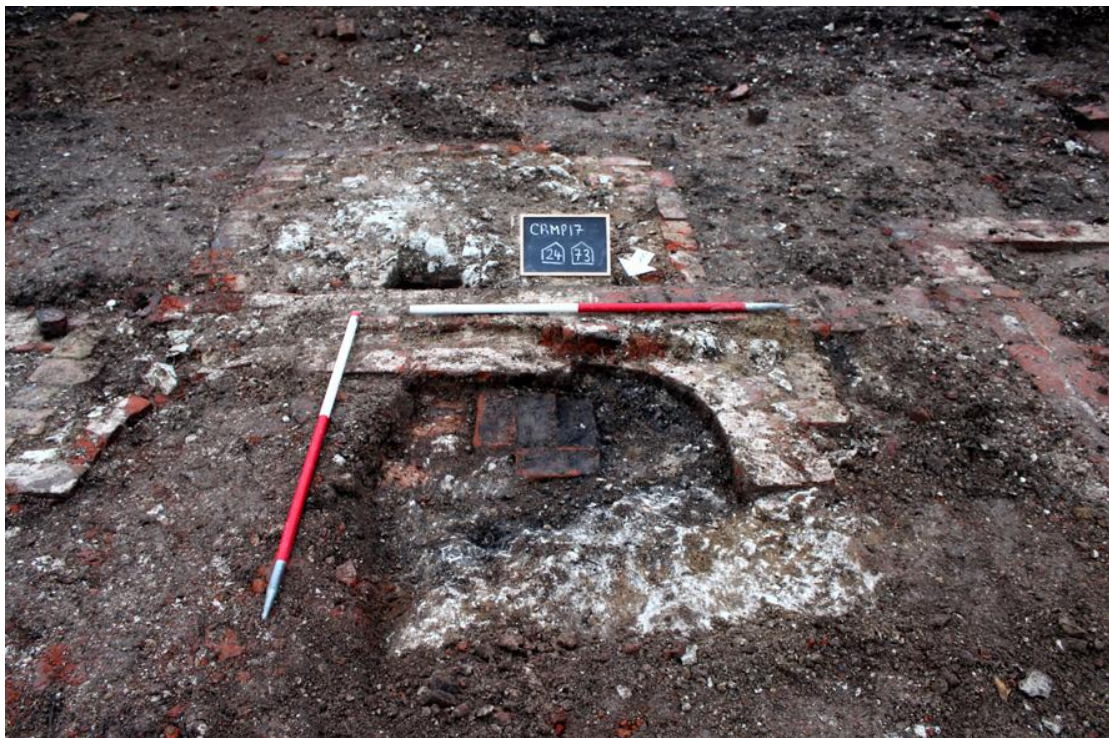
Plate 7: Fireplace **24**, showing remnant hearth and bedding surfaces.

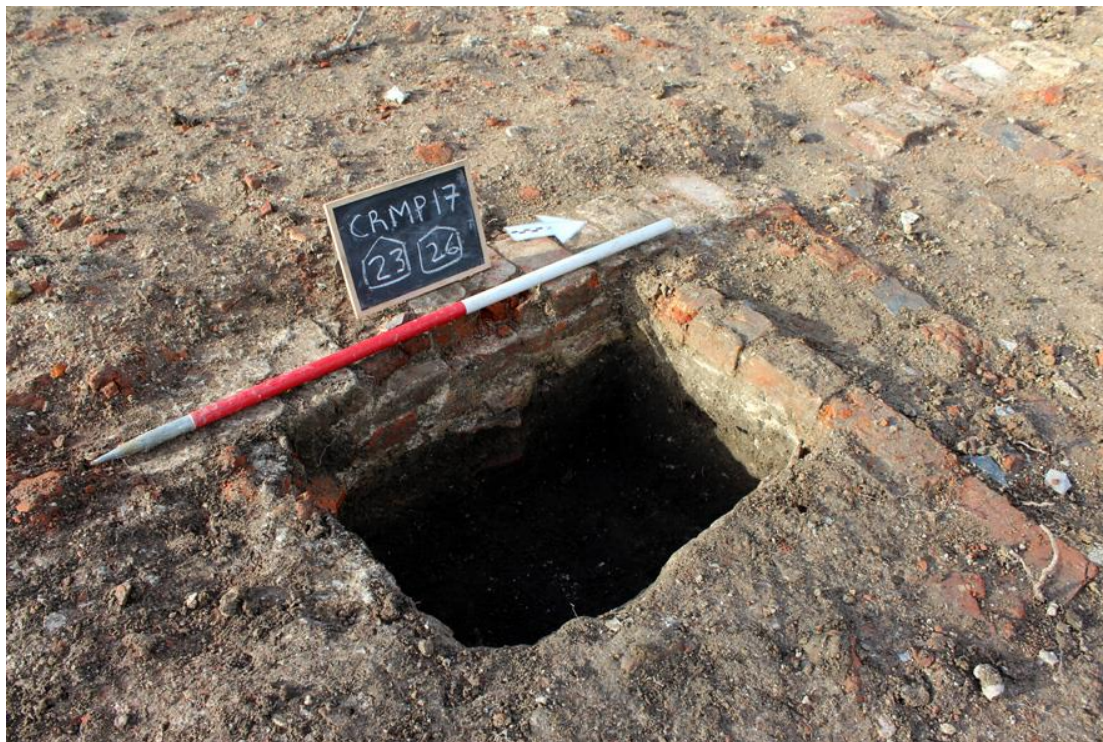
Plate 8: Walls **23** and **26**, showing associated bedding layers overlying earlier cultivation soil.

Elsewhere the sequence was not as complicated. An intervention placed next to walls **23** and **26** recorded deposit (94) a firm mid brownish grey clayey silt 0.12m in thickness and >0.75m in length by >0.5m in width (Fig. 6: Section 11. Plate 8). This was overlain by (93); a compact light grey clay 0.2m in thickness. This deposit was very similar in form to (97). An intervention placed against fireplace **24** recorded deposit (87), a firm mid brownish red silty sand >0.85m in length by >0.5m in width and 0.08m in thickness (Fig. 6: Section 9); this deposit overlay cultivation soil (64) and was overlain by (86) and **73**. **73** comprised heat affected bricks set in mortar and was interpreted as the fragmentary remains of the hearth. This was butted by (86) a firm light whitish grey chalky clay 0.2m in thickness. Deposits (86), (93) and (97) are likely to be contiguous; having been laid within the interior of the building to bed a

floor that was subsequently removed during demolition. Internal walls **21**, **26**, **27**, **28** and **29** were also bedded within this deposit. Walls **27** and **29** were overlain by concrete floor (31) (Fig. 5); this floor, a dark grey concrete with fragments of brick and stone, was heavily truncated but survived in the north east of the room over an area of 1.7m by 1.6m and to a depth of 0.05m.

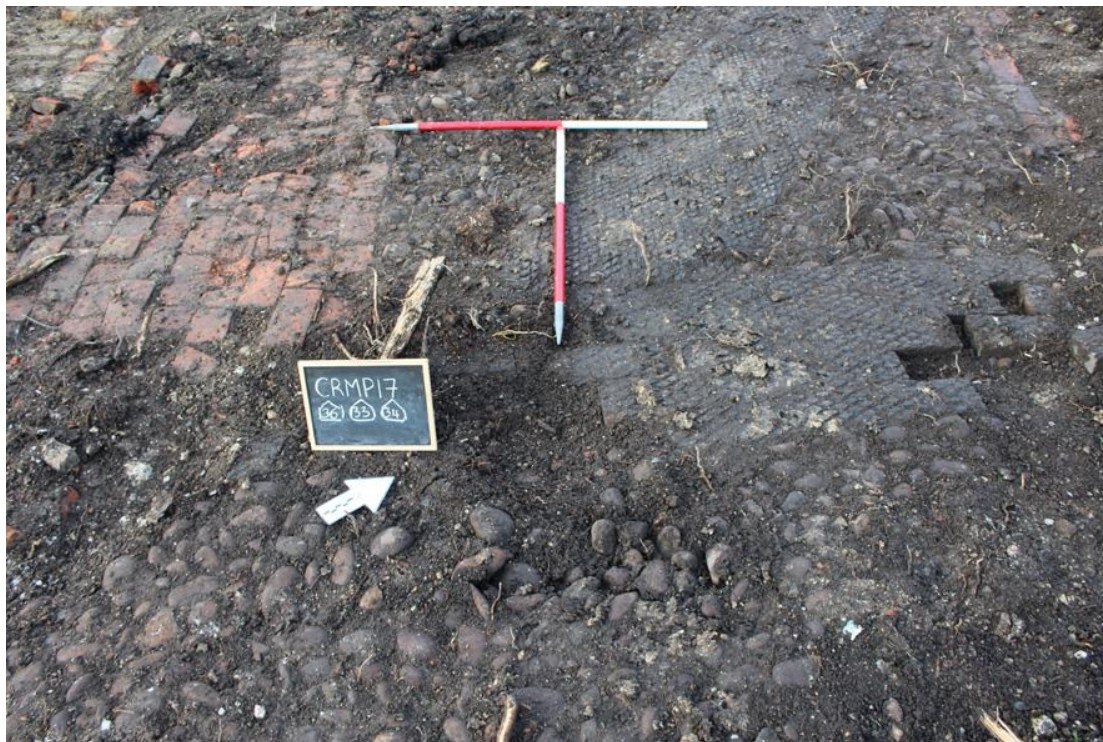
Plate 9: Exterior surfaces **33**, **34** and **36**.

Three exterior surfaces were present in the eastern third of the site (Fig. 5. Plate 9). Cobbled surface **33** was the most extensive of these; this surface measured 6.8m in length, 2.56m in width and 0.05m in depth. It was built from waterworn flint pebbles with an average size of 60 mm x 50 mm x 40mm and bonded with a dark greyish brown clayey silt. Walls **25**, **32** and **37** formed the northern and western boundaries of the surface while to the east and south the boundary was formed by wall foundation

35. Associated with this surface was brick path **34**; this was built from diamond patterned-frogged bricks measuring 250mm by 120mm by 60mm and set in a stretcher bond. The pathway measured 0.6m in width and had a depth of 0.06m and ran south from wall **37** for a distance of 4.0m before substantial truncation by tree roots obscured the intended course onwards.

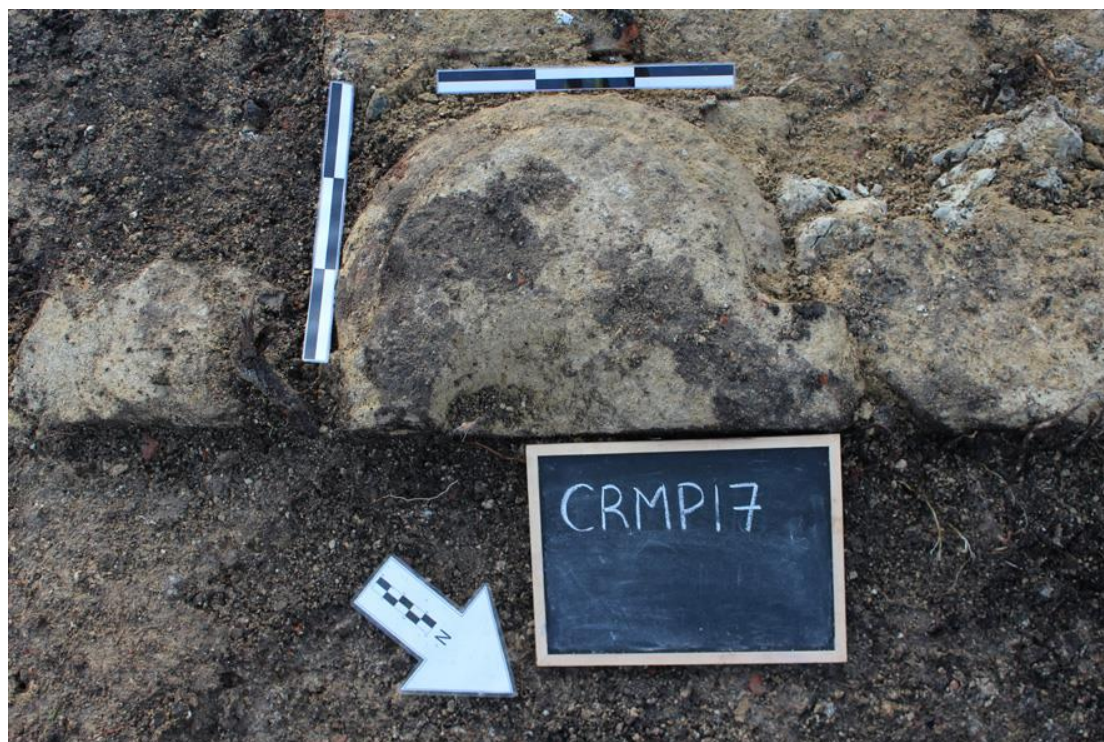
Plate 10: Worked stone 3.

WS3: Context 47 (Plate 10): Piece of limestone of a yellow colour (oolite or ragstone) measuring approximately 510mm x 360mm x 210mm. The stone was only viewed in photographic form and, therefore, oolitic limestone is only the most plausible piece. The comments from WS1 as to the composition also apply here. The piece has been reused it was undoubtedly circular in form with a diameter of approximately 510mm. The piece is derived from a column, being either part of an upside-down capital or a column base. In probability it is probably part of a column base. The edge of the moulding does not appear to survive without erosion, but it would seem that this is probably a roll or a keel in a circular form around the base, forming what would be called a torus. The tori are divided by a scotia. In this particular example the lower roll forming a torus dips down, thus creating a profile in which water could be retained. If a column base these mouldings were called Water Houlding Mouldings and were in use in Early English architecture of the late 12th and 13th century. If a capital this would have to be part of a Bell Capital (Verey and Brooks 1999, 769-794). The reuse saw the removal of part of the column base to create a flat side.

The first two stones WS1 and WS2 are not overly distinctive enough in their design and survival to provide a precise architectural date. WS3, however, is a different matter as it is more elaborate in its design and appears to show traits that indicate that it is highly plausible that one of these pieces of sculptured stone was re-used from a building of a late 12th to 13th century date. It is possible that the other two could be reused from the same structure, but this cannot be considered conclusive.

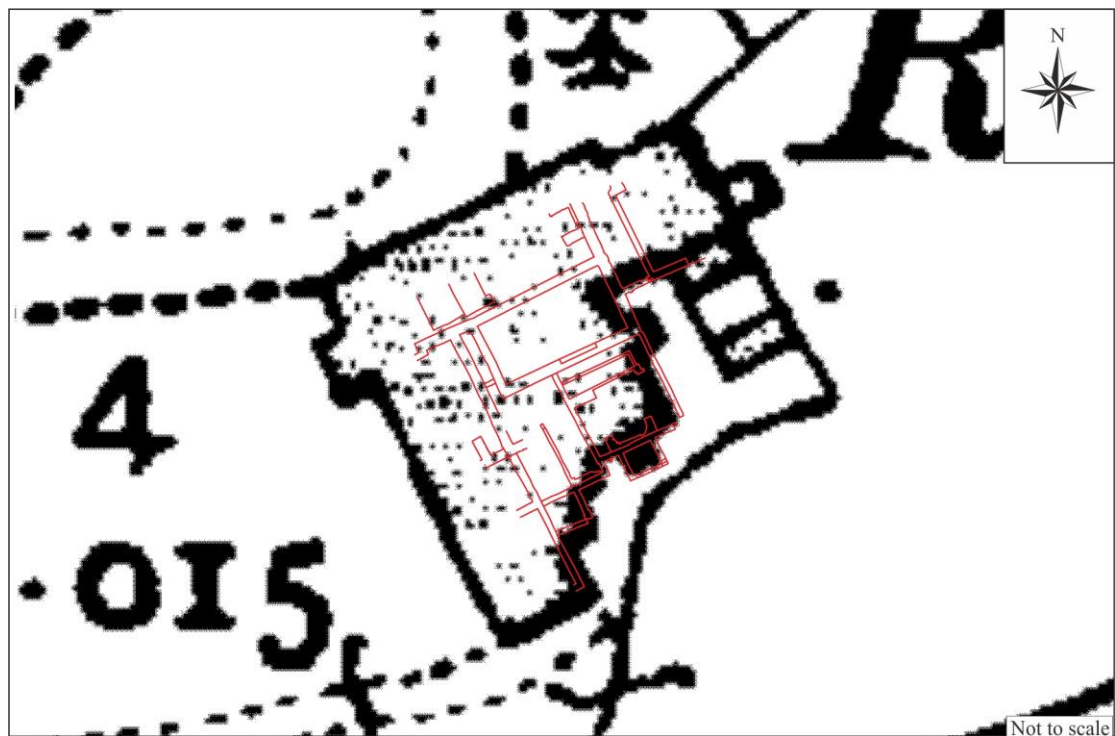
Plate 13: Ordnance Survey Second Edition of 1899, with overlay of walls recorded during excavation (Oxon XLIX/15).

The configuration of the house itself does not change between the 2nd and 3rd Edition maps of 1898 and 1912, however the walled garden is not shown on the 2nd edition and by the 3rd edition the boat house has also been removed. Plate 13 shows the position of walls recorded during excavation overlaid on the Second Edition OS map of 1899 in order to give an indication of possible rooms within the building.
